DATE: 08-05-2021

FIRE SYSTEM STATUS REPORT

IGMH

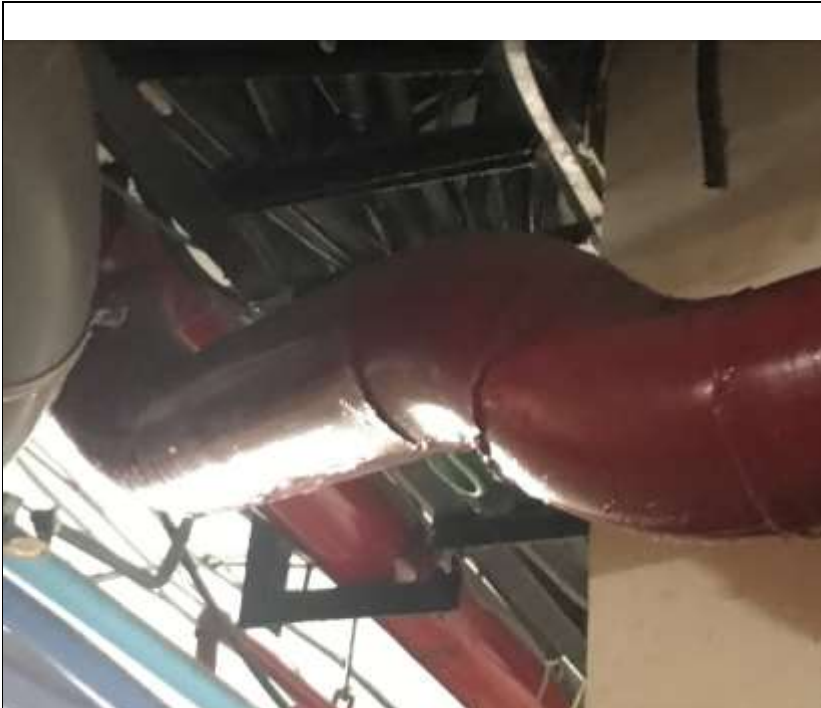
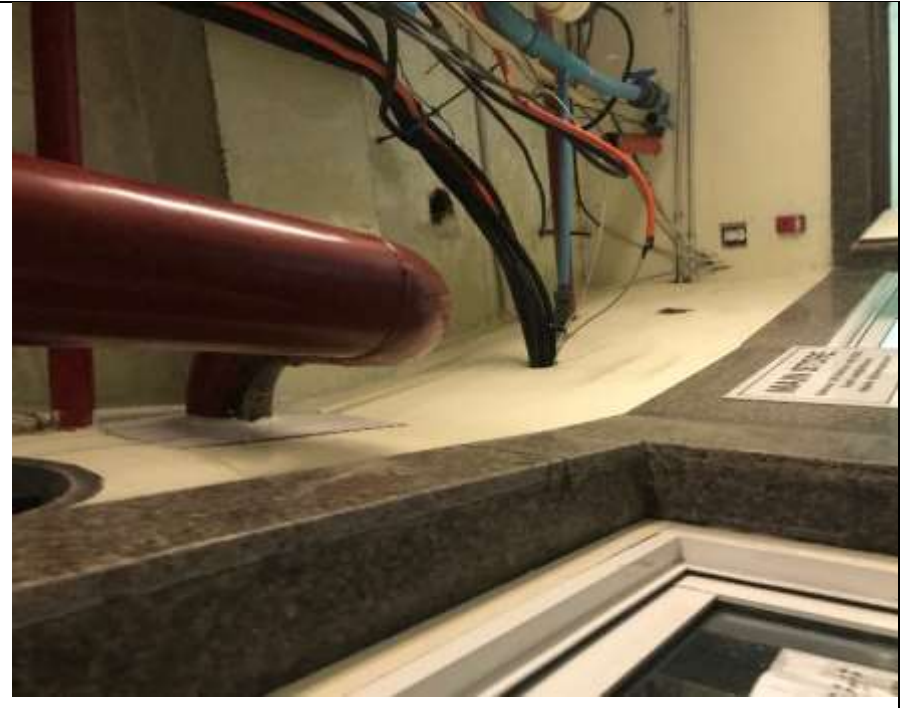
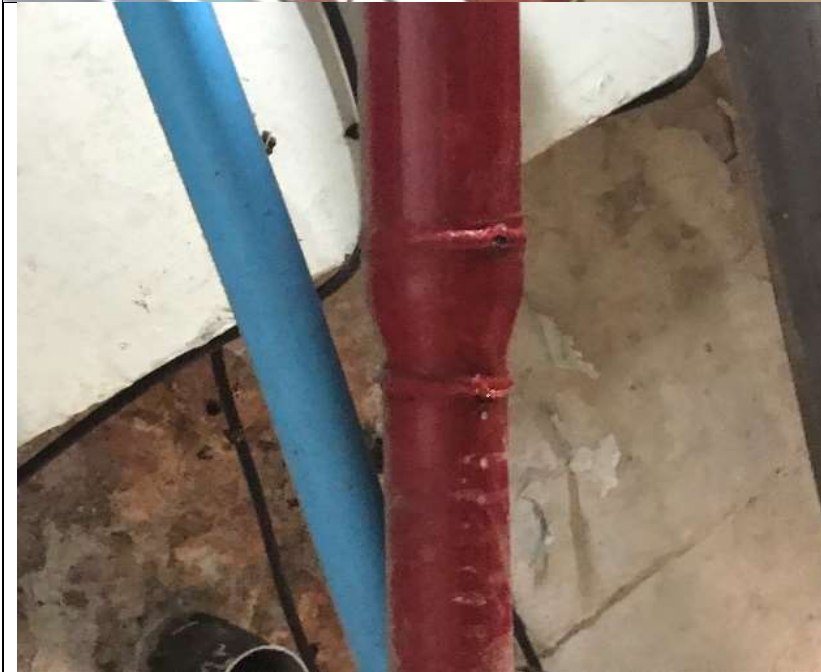
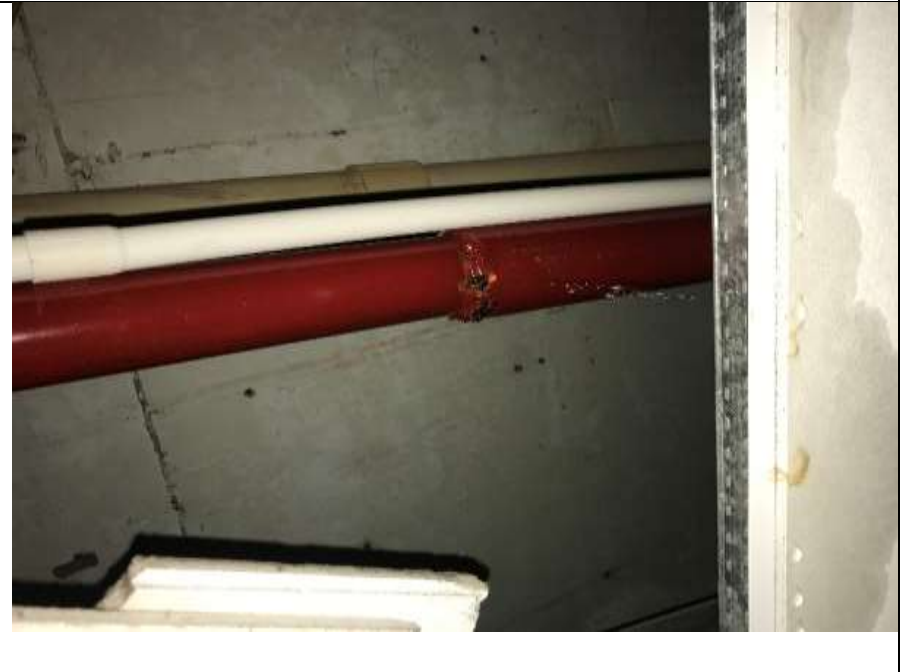
A Fire System drill was conducted at **1.5 Bar** and noted 10 issues that require rectifying have been identified including leaking pipes and broken sprinklers.

1. Pipe joint leak (CSSD entrance)
2. Sprinkler joint leak (CSSD corridor)
3. Pipe leak (CSSD corridor)
4. Leak through ceiling in a room in CSSD. The leakage not visible.
5. Main pipe joint leak (hallway)
6. Main pipe joint leak leading into Medical Records Room
7. Pipe leak (in front of stairway)
8. Wet riser pipe reducing joint having lot of water leaks (4 to 3 inches)
9. Laundry area broken sprinkler
10. Pump room main pipe leak

As per the fire sprinkler test run, noted there are 10 nos of water leak points at 1.5 bar water pressure due to severe corrosion spots. Therefore, it is very difficult to go for repairing the fire fighting system under this condition and it is worth to go for a new firefighting system instead of repairing old system.

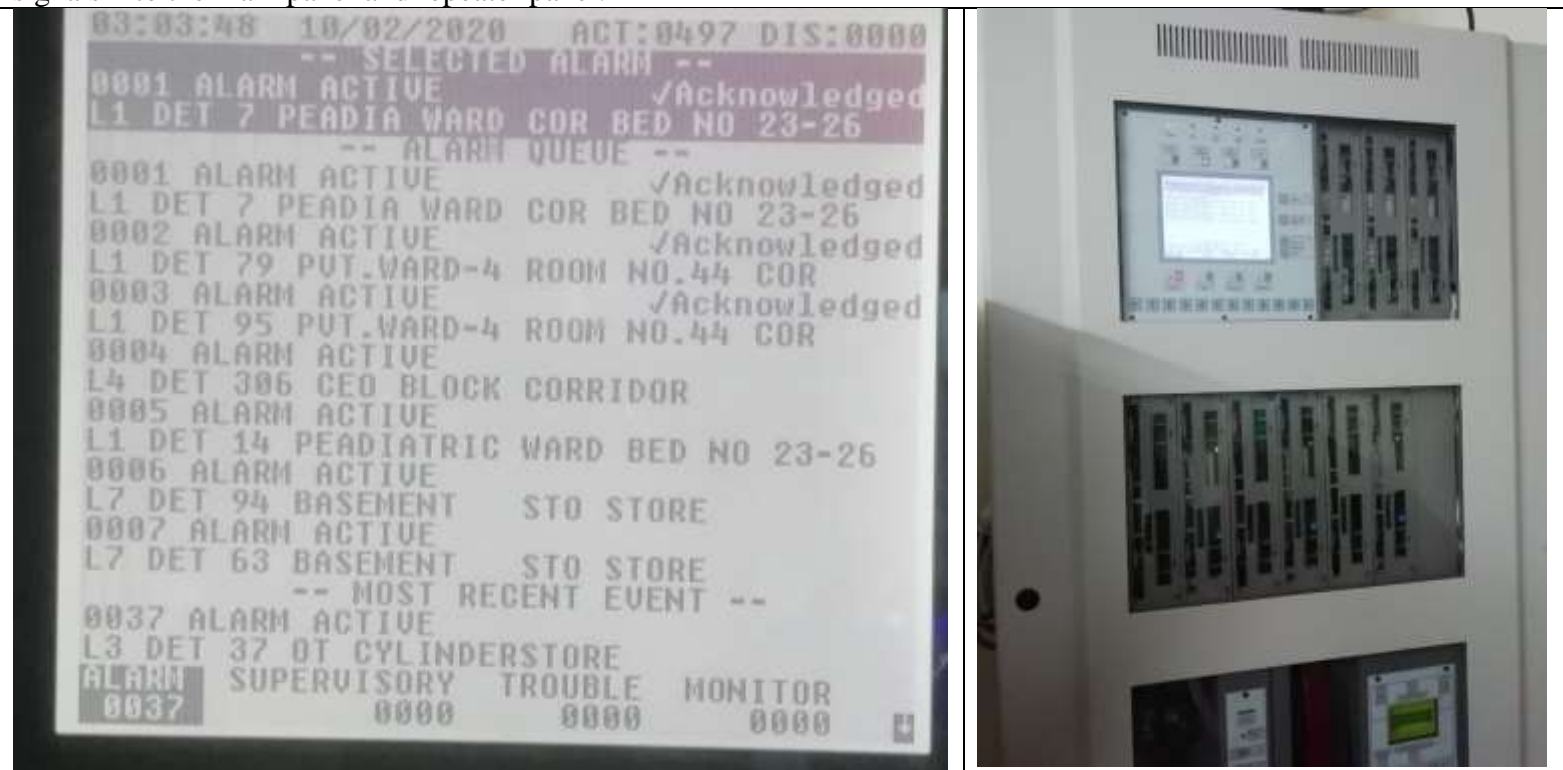
As per the site inspection had On 17/09/2020,IGMH fire detection system was not working on good condition since long time and also,noted there were not periodical testing and rectification have not been done since long time. Therefore,existing system is not in working condition and it has to be commissioned back ensuring all fire detection signals into the main panel and repeater panel.

In addition, the fire detection system presently is not in operational condition due to the defective fire detectors, disconnection of wiring intermediately, improper function of the main detector panel etc. Further; it needs to be extended over the area added newly to the IGMH premises.

Scope of the work as below

- Identify the connectivity of smoke detectors, flame detectors, manual call points, and fire pumps with fire detection panels
- Rectify all technical issues and set alarms free.

- Set of the dedicated existing desk top for the FDS
- Proceed the test run
- Commission back to operation.

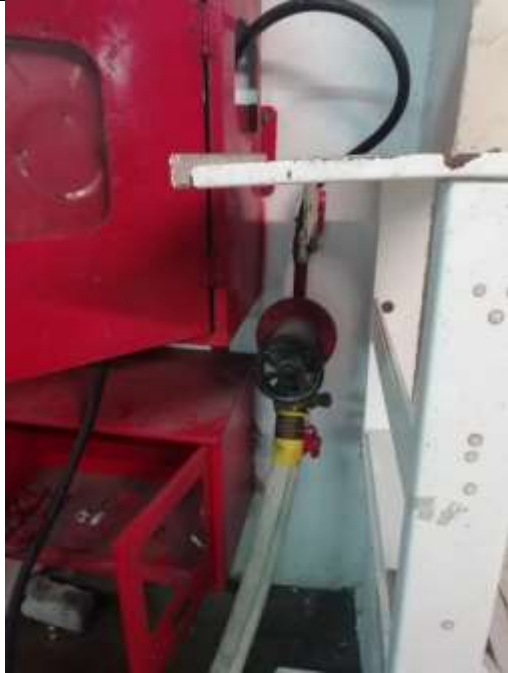
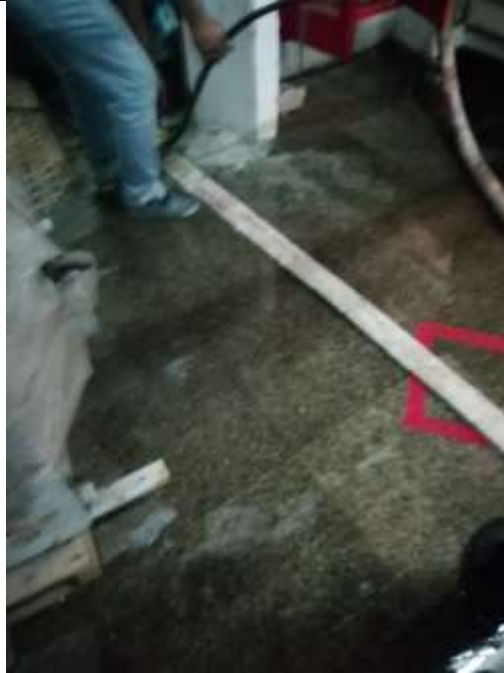
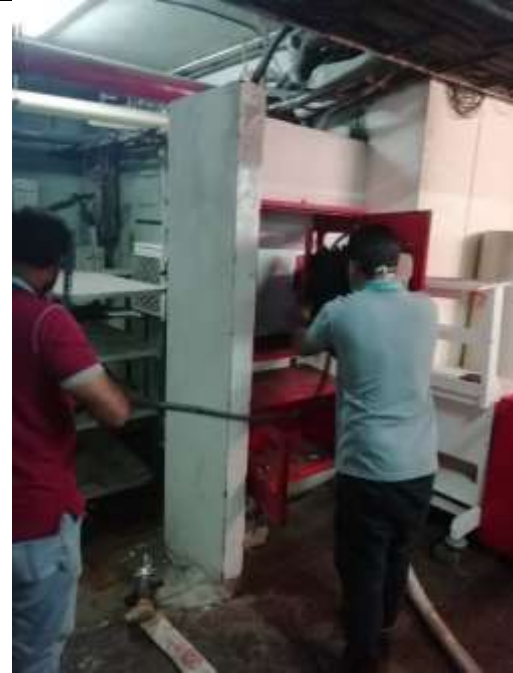
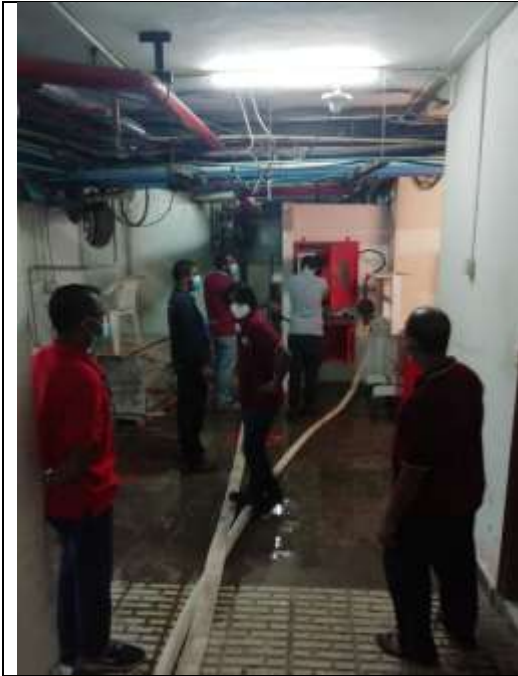
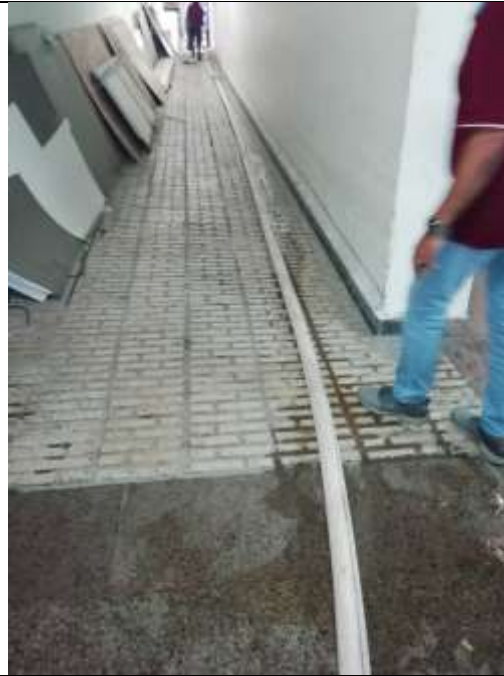
IGMH Basement area fire sprinkler system test on 30/08/2020. Noted there are water leaks from the main isolation valve for the wet riser water pipe that goes to the whole area of the IGMG fire hydrant points. Therefore, that main gate valve (150mm) need to be replaced to proceed the pressure test of the sprinkler system.
