# Report on the existing condition assessment of Equatorial Convention Centre

Prepared for:

Ministry of Housing and Infrastructure

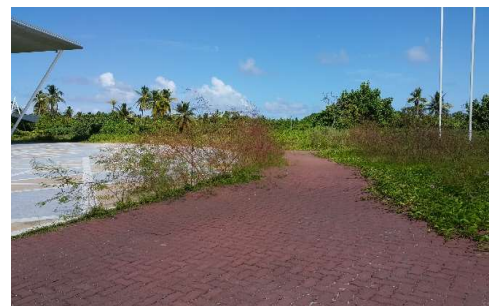
The present general condition of the site is extremely poor. The site is in this condition by pure neglect and no attempt being made to maintain or even prevent damage to the site and exposed elements of the site, as a result

- All walkways and pathways have lost levelness and is now loose and rough

- Paving bricks and blocks has been intentionally removed from pathways leaving voids and dangerous obstacles
- Nature has reclaimed the site to its original marsh land condition, all areas are overgrown.
- The landscaping of the site has lost all plan and concept and is wild overgrown.
- Pathways, emergency access points and curbs are now lost to overgrown vegetation.
- All external security cameras and lights without exception has been vandalized and most removed
- External electrical grid need complete replacement as it has been vandalized
- The wide terracotta decorative arrival area for general public is mostly intact, but some sections need replacement. The structure seems to have been used for motorcycle trick stunt driving. Burned tire tracks are evident some fresh some fading in all areas of the terrazzo work.

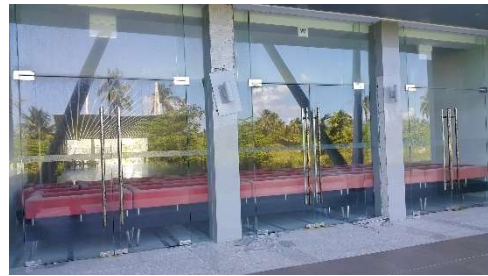
The external face of the buildings frame and envelop is in a depressing and decrepit condition purely out of neglect and total lack of care and maintenance. The building has not had any benefit of even general housekeeping. The north face of the building is covered in spider nest, and rodent excrement. The southern face has been vandalized with graffiti.

As result of this the external faces of the building, is in very bad visual state. Most notably

- Some vertically placed ceramic tiles has come loose of the building
- All door hardware on the external is now rusted and needs complete replacement
- The lights including those on the buildings ceiling soffits are now completely damages and most vandalized and need complete replacement.
- The curtain wall envelope is discolored due to accretion of dust and weathering and exposure to sun without any care.
- Wood and laminate doors exposed to the elements needs replacement

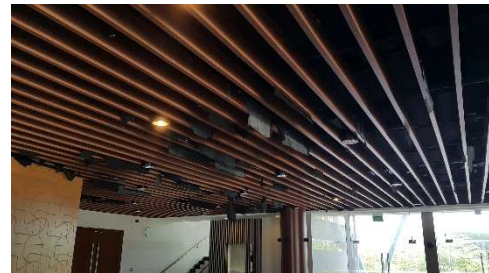
The cloth/woven material backdrop material of the general entrance foyer has completely disintegrated in the strong reflected sunlight and UV in the general entrance foyer with is large glass doors. This material does not seem to be UV resistance and is falling apart under its own weight. However this is restricted to that material only. The integrity of the ceiling structure, or the lighting and climate control infrastructure it supports is not affected. Should the re-purposing of the building require this ceiling to be exactly as it was, then it need the fabric material replaced, and no other changes.

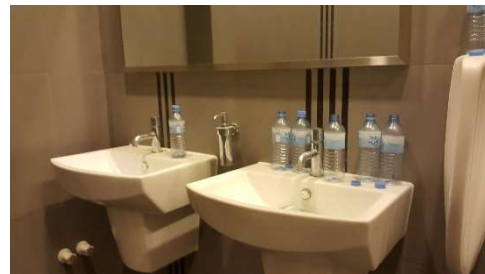
However the toilet blocks have been in use with the aid of small desalinated water bottles, which clutters and pile up in all toilets blocks. This leads inadequately flushed toilet facilities, resulting in staining, and the seizing up of all the fittings, and generally bad visual and smelly condition of almost all the toilets.

The toilets of the VIP area does not seem to have been used, and is in clean (except for rodent excrement) but dry condition.

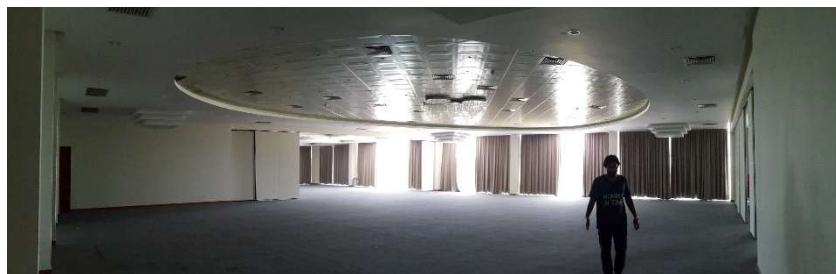
The cooling systems and Air circulation system is in good working condition.

Some Air-conditioning cassette systems need servicing, however all except one unit

we tested during the inspection is working, and need routine maintenance. Generally the HVAC system is working condition.

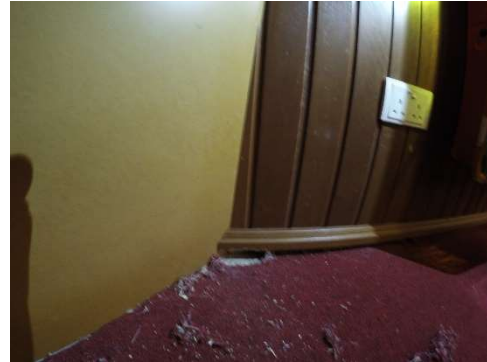
As reported previously, the entire building is infested with rodents. As the building is primary a structural frame with cast in place slabs, and masonry wall, most of which is clad with false surfaces, there are many gaps and pockets within the building. It is evident the rodent infestation is spread to all there voids.

If as informed by client, the building is to be repurposed as a healthcare facility, then it would require that all these false surfaces and cladding be opened, inspected cleaned and treated to clear all rodents.

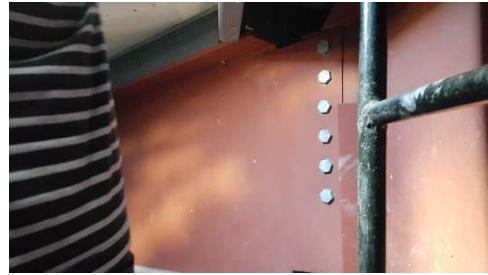
The structural frame of the building was found to be in excellent condition. NO signs of structural distress was noted at any location in the building. The visual condition of the elements was also in excellent condition.

All location gave excellent strengths, and on detail visual inspections, the inspectors were satisfied that the buildings structural frame is in very good condition.
