VISUAL SOIL INSPECTION REPORT FOR WAREHOUSE , K.MANIYAFUSHI

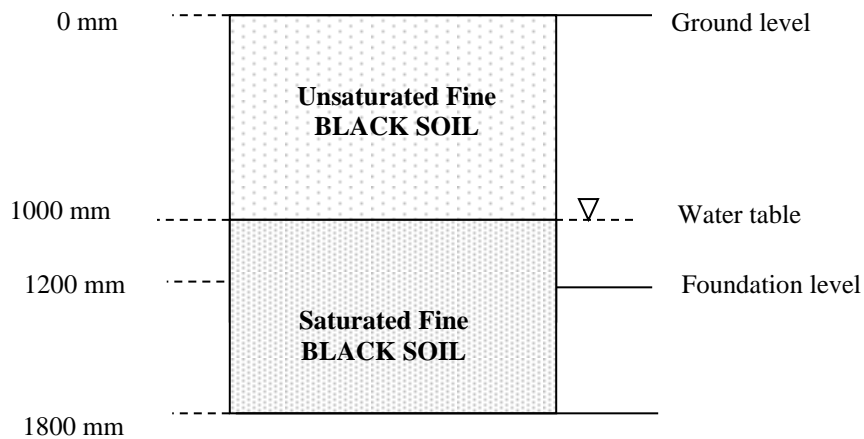
A pit of depth 1.8m was used for the visual soil inspection.

Following diagram represents the soil profile.

Foundation to be laid at 1.2 m below the natural ground level. Dewatering will be required during foundation construction.
