Environmental and Social Impact Assessment Report

Upgrading of infrastructure at Regional Waste Management Facility Zone II, Raa, Vandhoo

Report Prepared by LaMer Pvt Ltd:

January 2019

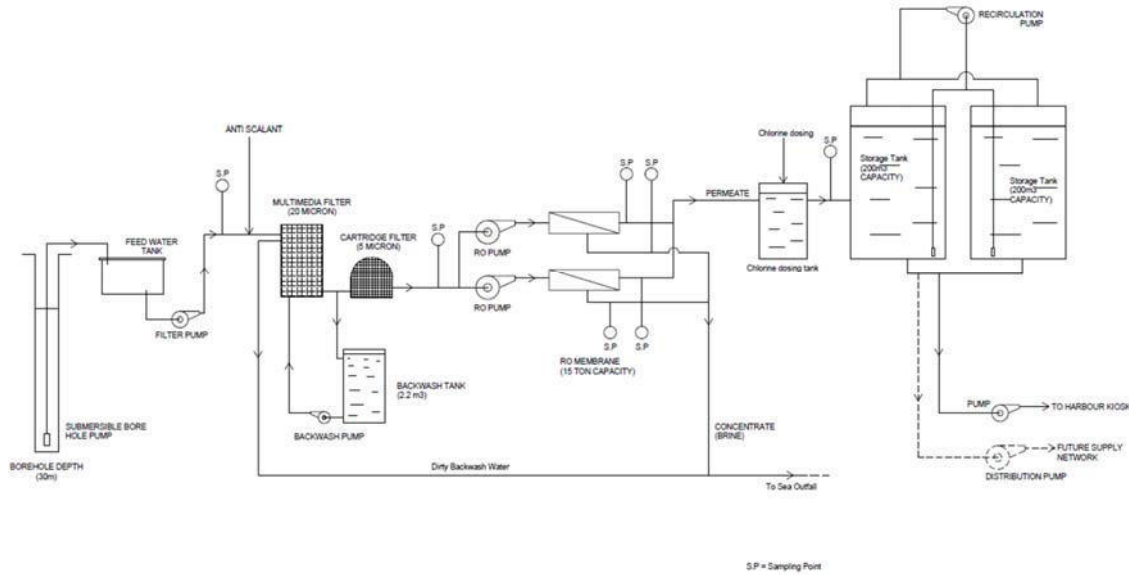
Figure 3. Typical water treatment process from borehole to water storage tanks

Properties of product water quality produced from the RO plant will be in compliance with EPA's guideline for drinking water quality.

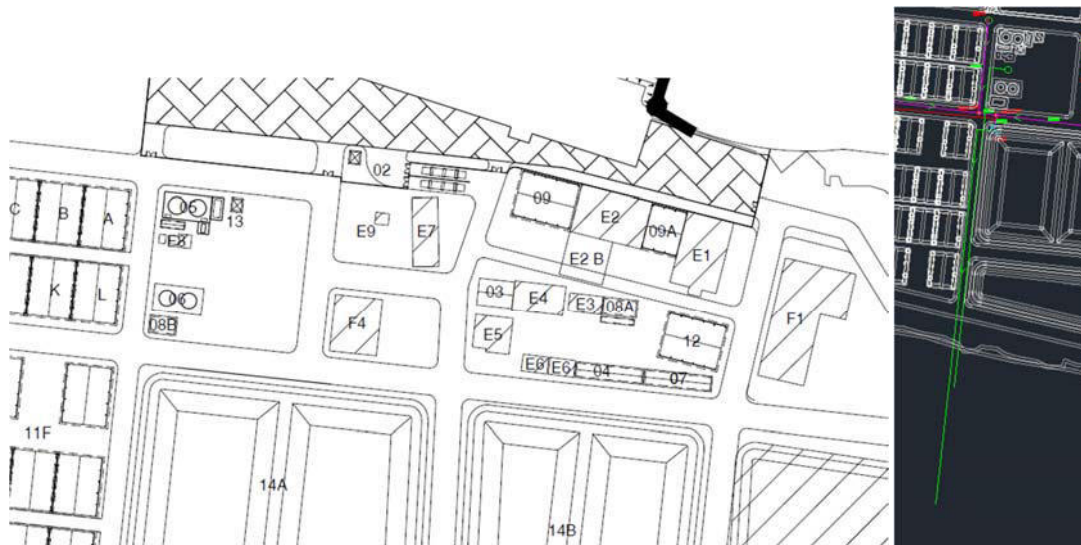
Figure 4. Location of utility building and brine out fall. Existing utility building is marked as E3. New borehole will be established adjacent to the proposed desalination building (image on right). Water storage tanks are to be established at building no. 06 and fuel and waste oil storage tanks at building no. 05. Building no. 08A is the proposed powerhouse and 08B desalination building.

It has been proposed to construct a new fuel farm near the harbor area with fuel supply pipeline (building no. 05 on Figure 4 and Appendix 4). The newly established fuel farm will consist of 2 x 200 m³ for diesel and used oil storage purpose. Refer to the drawing in Appendix 6 for the location of inlet and outlet pipes of fuel transfer. Oil storage tanks will be constructed with carbon steel with flat steel flooring for placement on concrete foundation. Moreover, existing fuel tanks will be relocated to the proposed fuel farm. Specifications of diesel steel tanks are attached on Appendix 7 of this report.

A Genset of capacity 250 KVA is currently present in Vandhoo located in the existing powerhouse. Moreover, an additional Genset of capacity 250 KVA will be provided at extension of existing utility building (building no. 08A in Figure 4 and Appendix 4). There is a backup Genset of capacity 120 KVA at the project site.

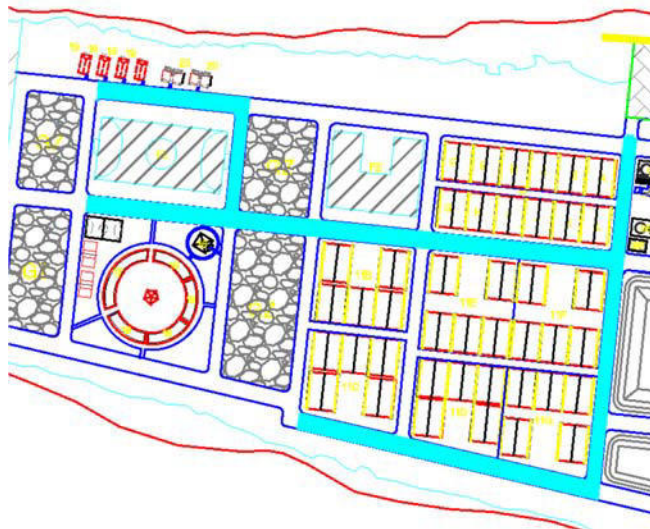
Figure 5. The roads proposed to be paved are highlighted in blue

Road paving is only proposed just enough to provide access to the buildings proposed to be constructed during this phase of the project (highlighted areas in Figure 5). The roads will have a 2m green zone, 1m side walk pavements, 1m green zones and curb stones on either side. Additionally, provision for pipelines for utility services under the road will be provided. Typical road section and road paving details are given in Appendix 8 of this report.

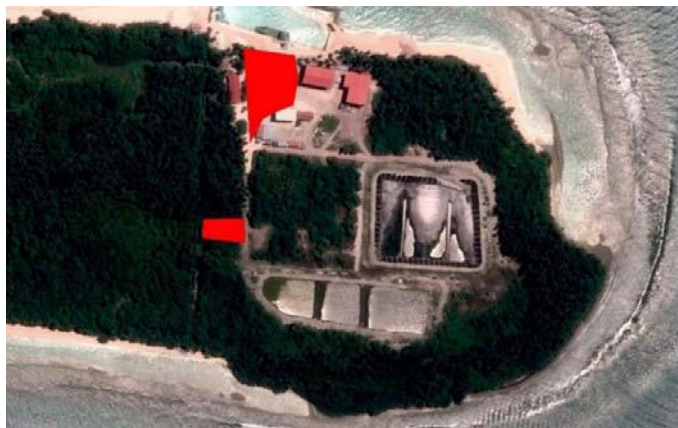
Figure 6. Recommended areas for temporary material storage

Construction material for the project, such as building material, galvanized iron pipes and nets will be brought to the island on bigger vessels. Materials will be unloaded to the island at the existing harbor. Construction materials will be temporarily stored at the areas indicated on Figure 6 below as these areas are currently barren. Vegetation clearance for temporary storage is not recommended. Once the land gets cleared for building plots, some material can be moved about to those areas as well.

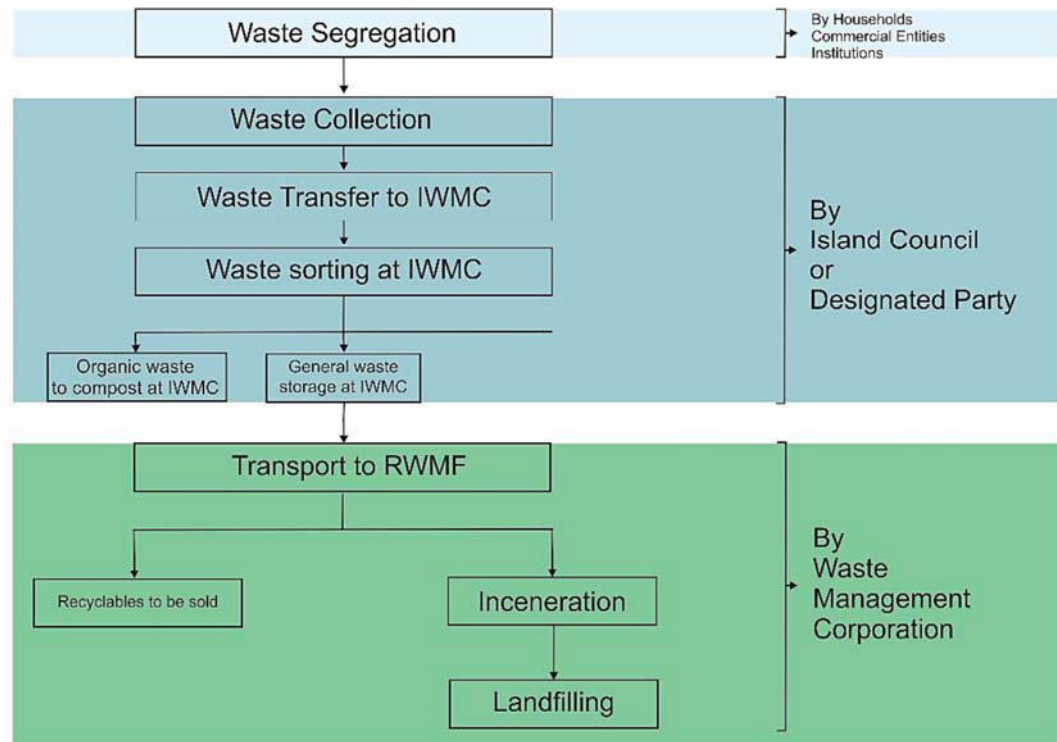
Figure 7. Waste management process flow from island waste management centers to RWMF

Waste management process is summarized in the flow diagram below (Figure 7).

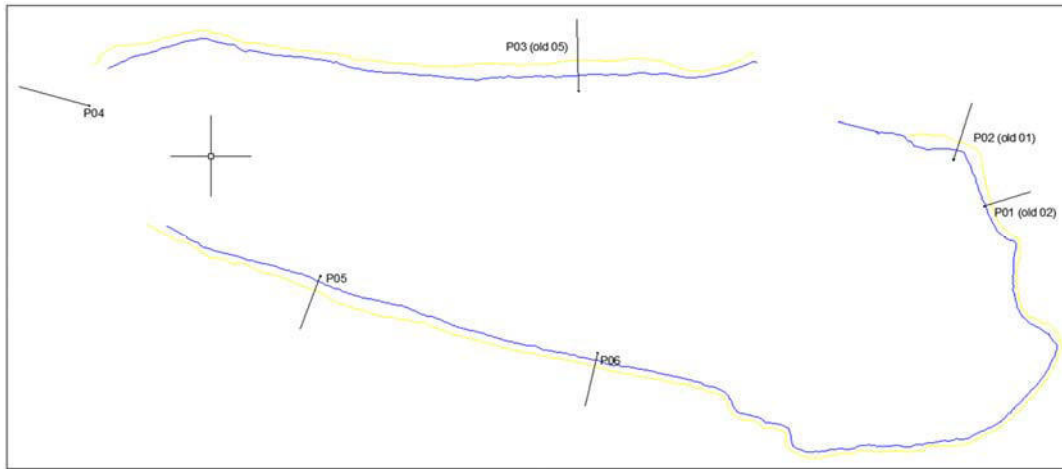
Figure 13. Beach profile locations
Table 7. GPS coordinates of beach profile locations

Beach profile locations are indicated on Figure 13 and GPS coordinates are given in Table 7 below. Beach profiles were taken using an electronic level instrument (Leica Sprinter 200M).

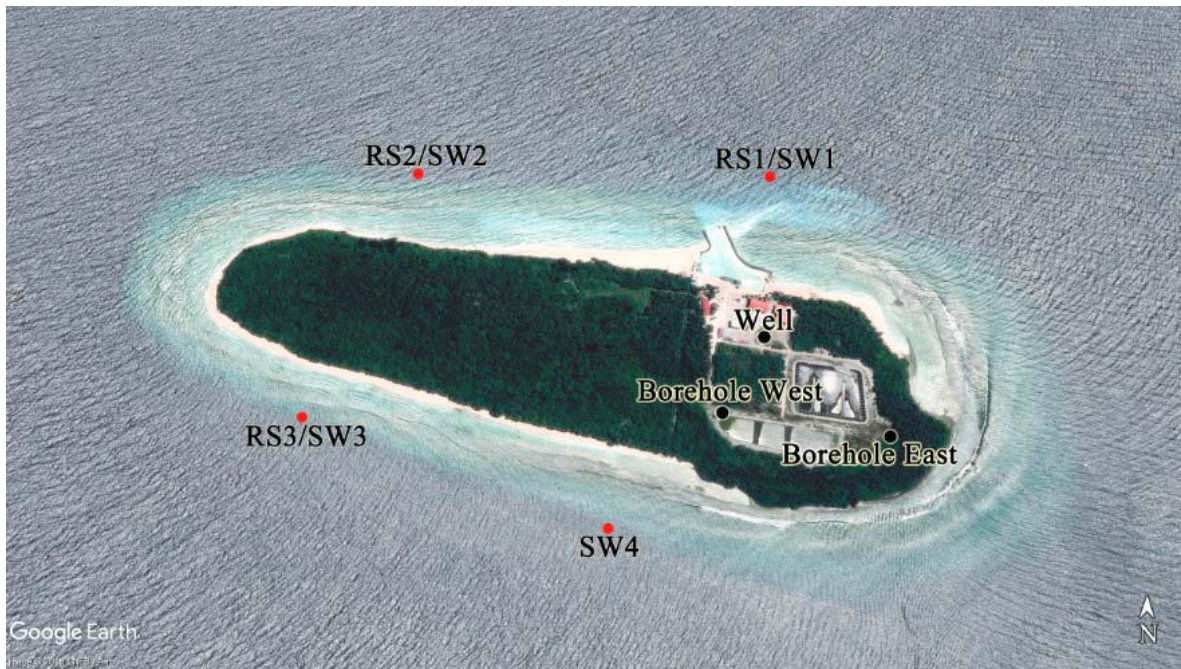
Figure 14. Reef survey and water sampling sites at Vandhoo

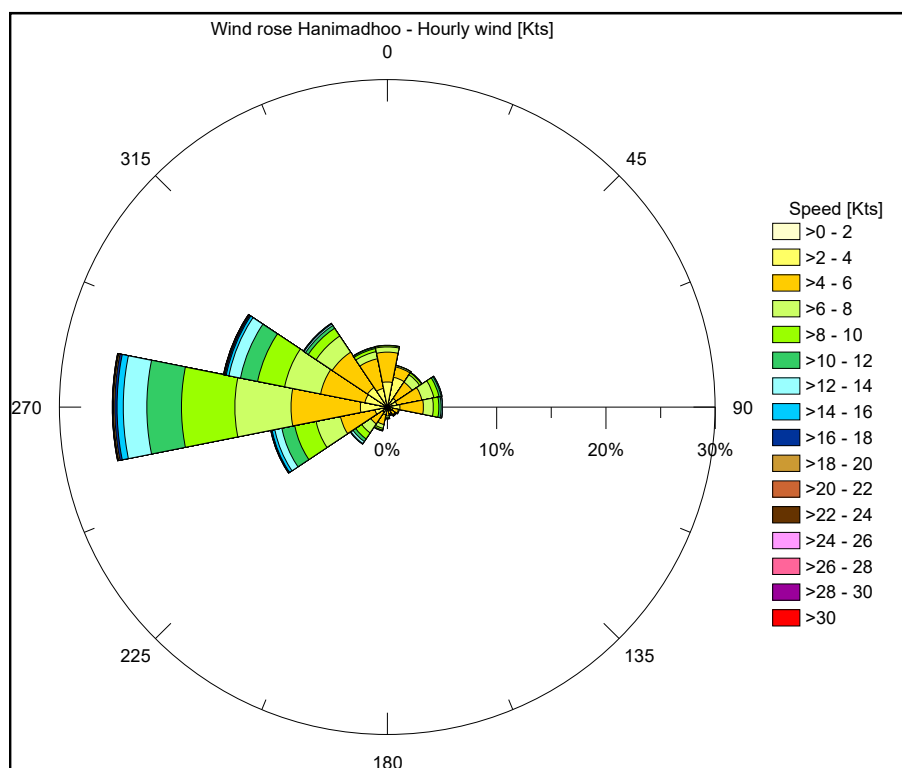
Figure 16. Wind rose plot for Hanimaadhoo Meteorological station, based on hourly wind data for the period of May 2008 to December 2012

Wind rose plot (Figure 16) shows that winds from the western quadrant are dominant reaching speeds as high as 30 knots. Winds from the northern and eastern quadrant are less prevalent and with comparatively low speeds. Wind speeds above 18 knots were found to be a rare occurrence, and the instances when it does occur, wind direction was from the western quadrant (Table 9), thus indicating that this was during the SW monsoon, when winds are generally stronger.

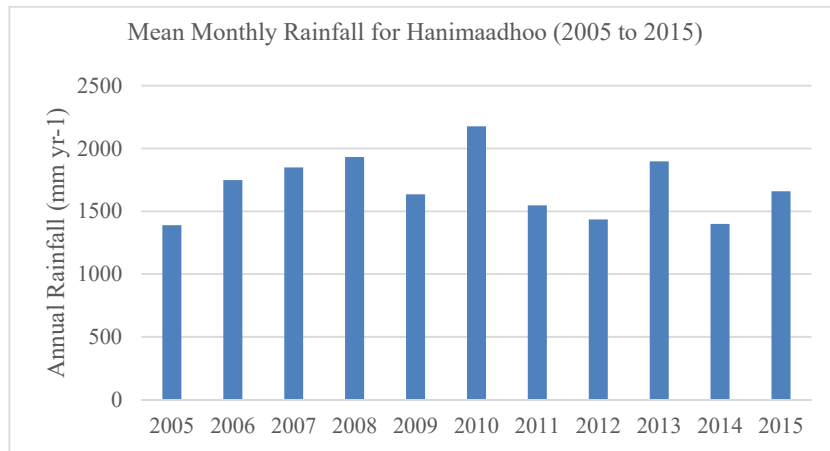
Figure 17. Rainfall pattern for Hanimaadhoo Meteorological Centre (rainfall data provided by Maldives Meteorological Centre)

Vandhoo is located in the northern region where the average rainfall tends to be less than southern regions of Maldives. This is corroborated by the weather records from the closest weather station, Hanimaadhoo and weather station in the South, S. Gan. Rainfall records indicate that the average annual rainfall is 1697.3 mm (Standard deviation of 251.0 mm) and mean monthly rainfall is 141.4 mm (Figure 17).

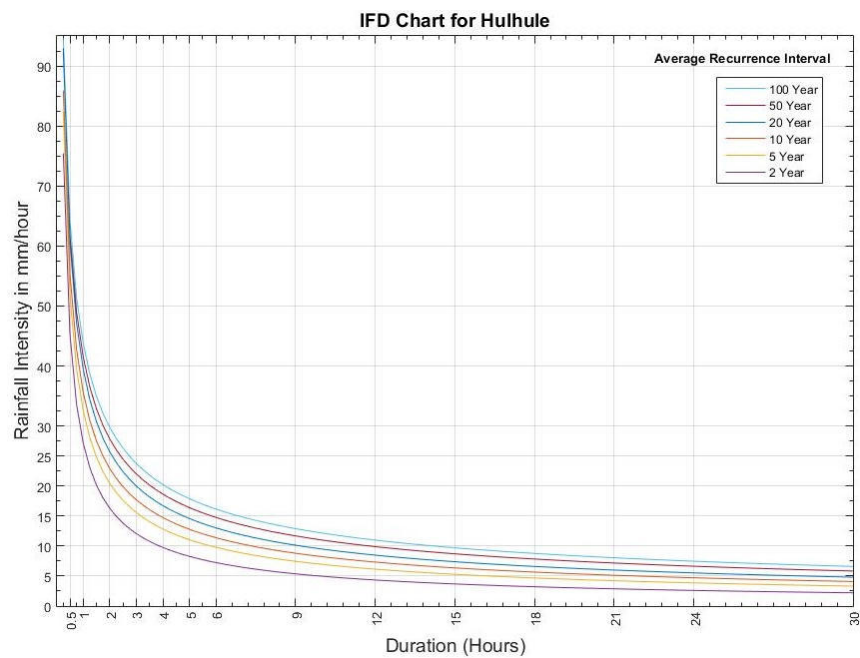
Figure 18. IFD chart for Hulhule (source: Riyan Pvt Ltd, 2017)

Intensity Frequency Duration (IFD) Curves was derived from data provided by meteorological department for the period August 2013 to February 2017 (Figure 18). In addition to this, three-hour rainfall data from January 2005 to July 2013 were also used.

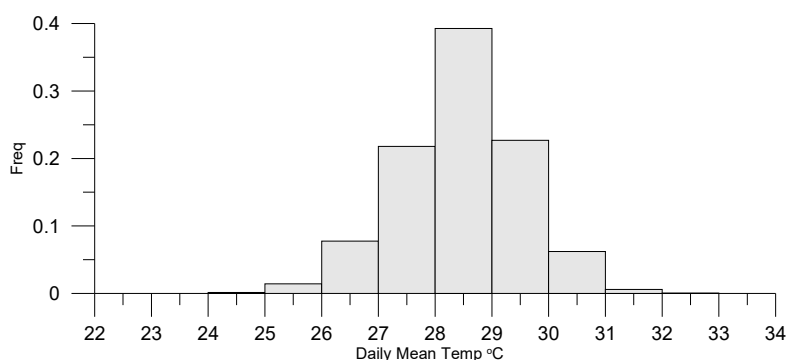
Figure 19. Frequency distribution of daily mean temperature recorded at HDh. Hanimaadhoo station (May 2008 – December 2012)

December 2012. The whole data set was analyzed to obtain a frequency distribution of daily mean temperature for the given period. Results of this analysis are shown in Figure 19, which shows that temperature in the region was most commonly at temperatures between 28°C and 29°C. The lowest recorded temperature was at 24.2°C while the highest recorded temperature was at 32.5°C.

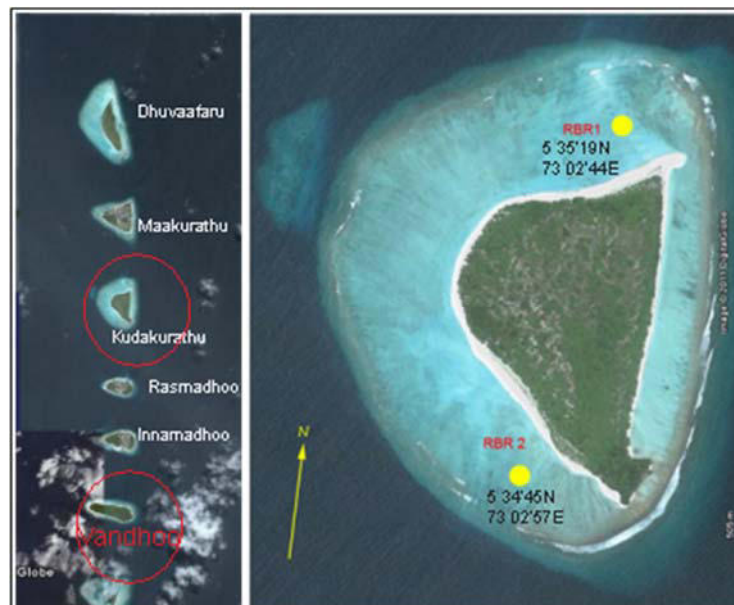
Figure 20. Location of Kudakurathu with respect to Vandhoo and location of wave gauges

Since site specific wave data is not available for Vandhoo; data collected at a nearby island (located at the eastern periphery as Vandhoo) was used to understand the wave climate of the area. The island of Kudakurathu is proposed for resort development and as part of Environmental data collection; LaMer Pvt Ltd has collected wave and tide data from this island. The island of Kudakurathu is approximately 4.7 km north of Vandhoo (Figure 20 shows location of Kudakurathu and wave gauge). RBR model TWR 2050 was used to collect wave data at 30 min interval burst.

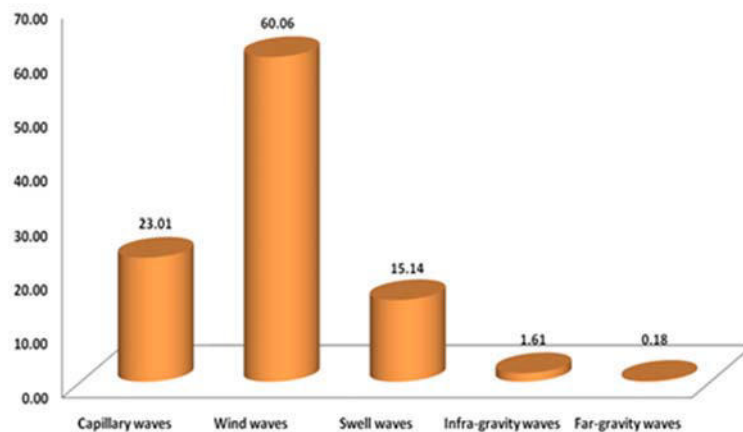
Figure 21. Types of waves observed on the northern side

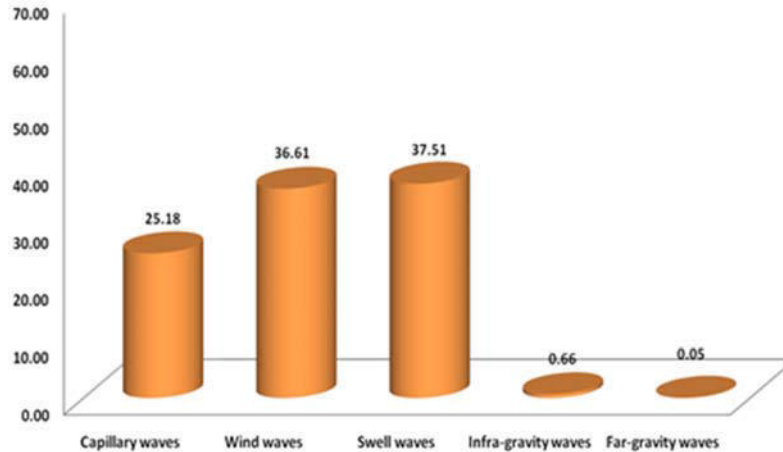
Figure 22. Types of waves observed on the southern side

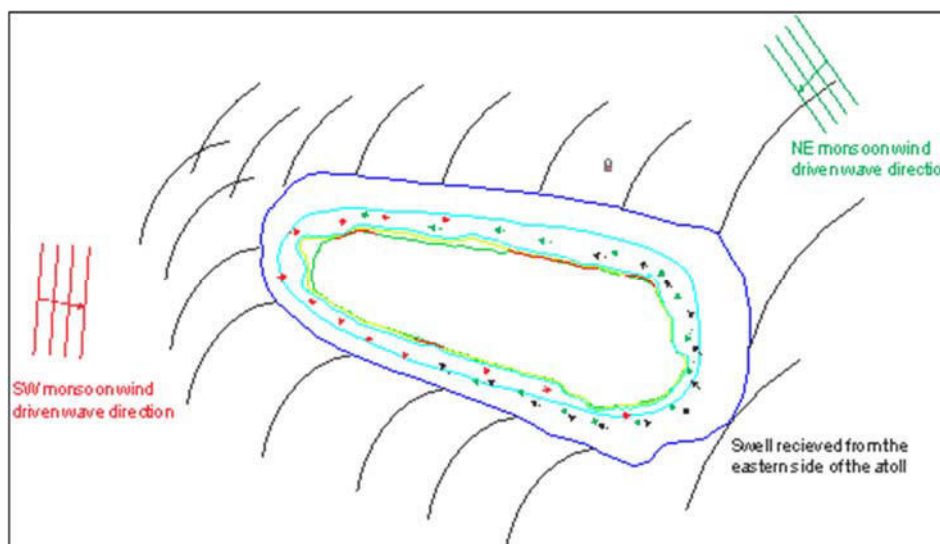
Figure 23. Assumed current regimes around the Vandhoo (colour of arrows represents wave types that generates current)

The swells breaking at the eastern side also creates a current east to westwards inside the lagoon at the southern and northern side of the island. Surface current which is associated with the monsoonal wind waves are strongest during the NE monsoon since swell, wind waves and current associated with tidal flux are combined. During the NE monsoon, wind wave induced currents will be flowing east to west at the channels, which will be coupled with swell induced currents. During the SW monsoon, wind wave induced currents will be in the direction of west to east and northwest to east (see Figure 23 for assumed current regime at Vandhoo reef system based on wind data).

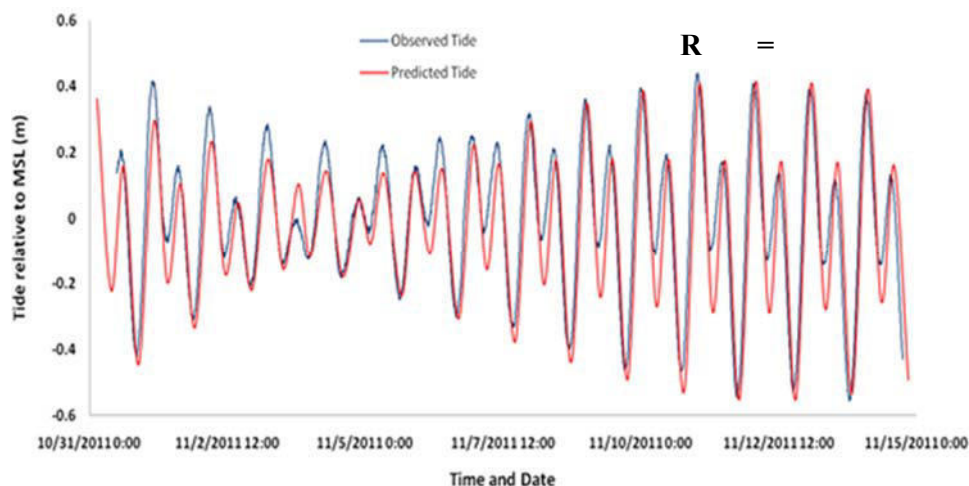
Figure 24. Tide measured by the tide gauge and the superimposed predicted tide

All coastal development projects require determination of the water level or water datum. The tide which consists of a number of wave forms, termed tidal constituents, generate many different water levels that are used as different datums. The most commonly used tidal datum in the Maldives is the Mean Sea Level (MSL). The Consultancy Team assumes that the astronomical tide at Vandhoo is the same as that at Hanimaadhoo (closest tide station – Figure 24).

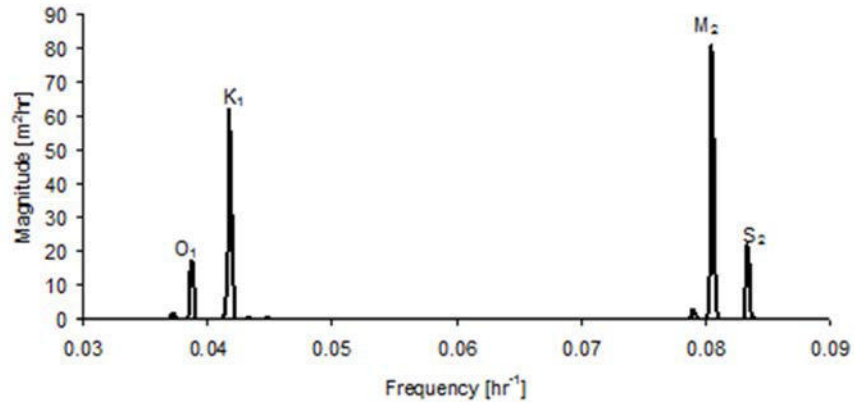
Figure 25. Spectral density for the tide of Hanimadhoo

Long-term water-level records for Hanimadhoo are available from the website of University of Hawaii. Analysis of the long-term tidal records from Hanimadhoo (November 2002 to November 2007) indicated that the tide at Hanimadhoo is a mixed diurnal – semi diurnal tide with a dominant lunar semidiurnal constituent followed by the Luna-solar declinational diurnal constituent (Figure 25 and Figure 26). The diurnal constituent of the tide at Hanimadhoo is 23% greater than the second largest constituent (Luna solar declinational diurnal constituent) (Table 11 and Table 12).

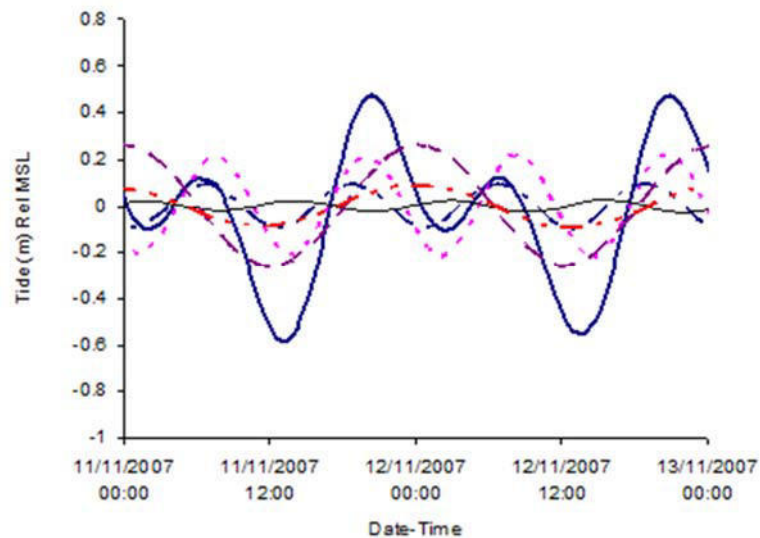
Figure 26. Time series plot of the dominant constituents of the tide at Hanimadhoo showing the significance of each of these constituents in the tidal signal

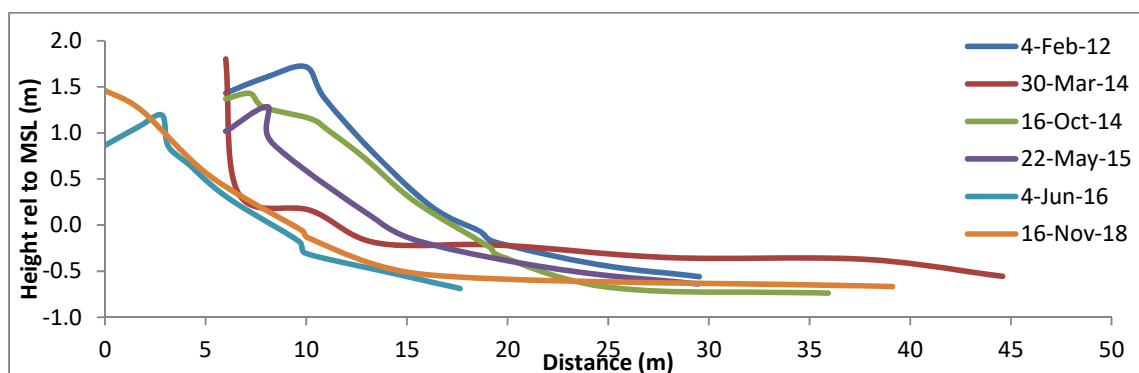
Figure 27. Beach profile P01 (old 02) showing shoreline characteristics from February 2012 to November 2018 at Vandhoo.

Beach profiles at P01 showed that the beach height had remained relatively stable between 0.9 m to 1.8 m. Sediment loss was observed at beach berm since baseline (Feb 2012). However, beach length was observed to have increased, indicating that the beach at this location had flattened (Figure 27).

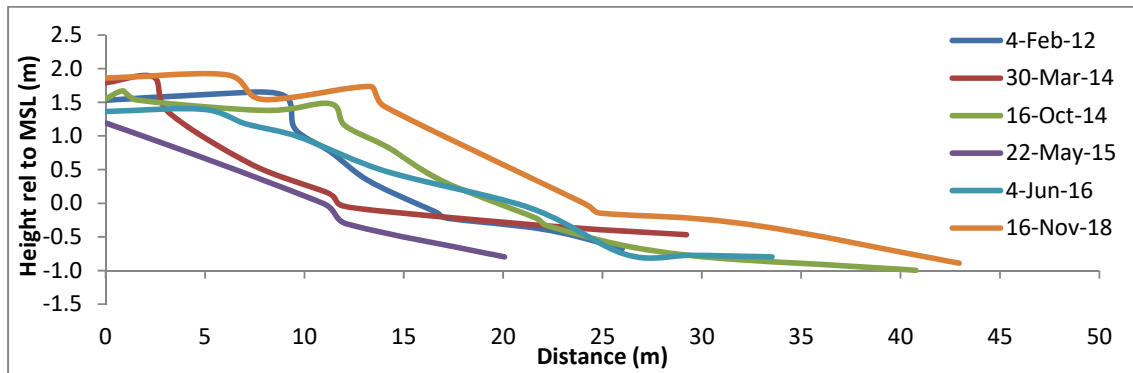
Figure 28. Beach profile P02 (old 01) showing shoreline characteristics from February 2012 to November 2018 at Vandhoo.

Beach accretion was observed at profile P02 area. Seasonal loss and gain of sand were clearly visible at this area, i.e. beach erosion was observed on March 2014 since Feb 2012. Beach accretion was observed on Oct 2016 and major erosion was observed on May 2015 which accreted on June 2016 yet again. Most significant increase in beach volume in terms of beach height and length was observed during the current survey period (Nov 2018) (Figure 28).

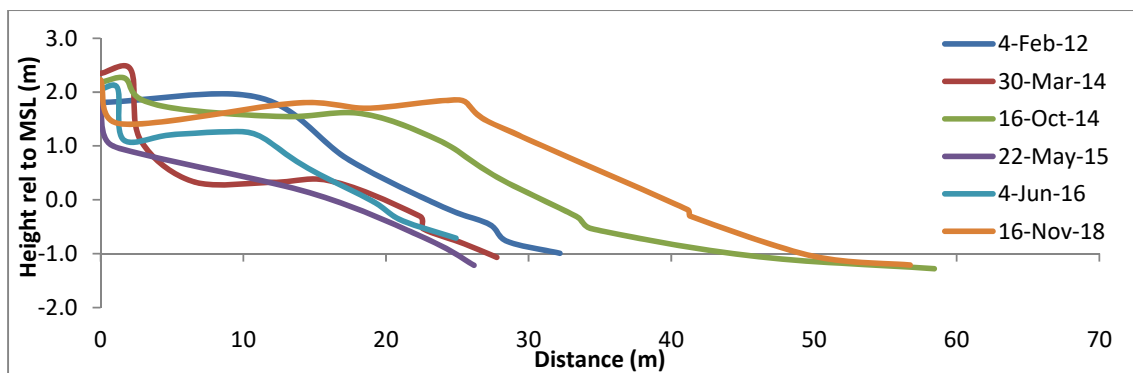
Figure 29. Beach profile P03 (old 05) showing shoreline characteristics from February 2012 to November 2018 at Vandhoo.

A similar trend in seasonal gain and loss of beach material was observed at P03 as well. Beach profile analysis further showed a significant increase in beach height and length compared to the baseline and monitoring dates (Figure 29).

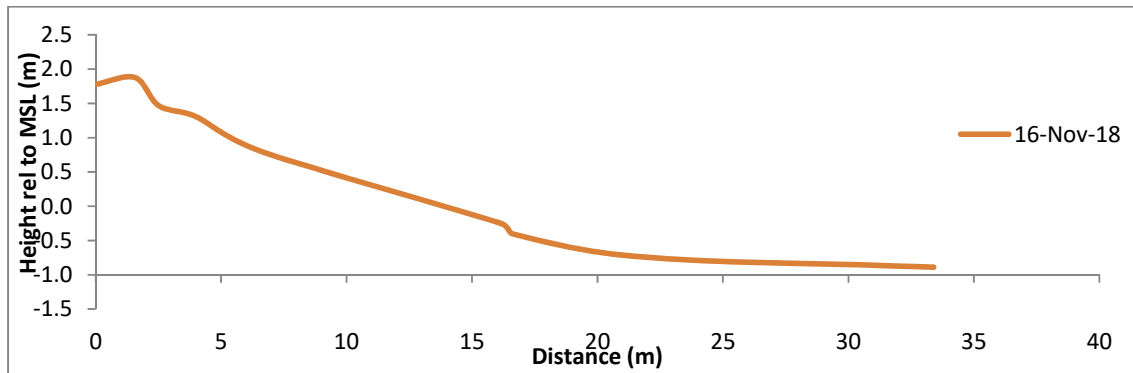
Figure 30. Beach profile P04 showing shoreline characteristics on November 2018 at Vandhoo.

New beach profiles were established at locations P04 to 06. Beach height at these locations were between 1.5 to 2.0 m and beach lengths were between 24 and 33 m (Figure 30 to Figure 32).

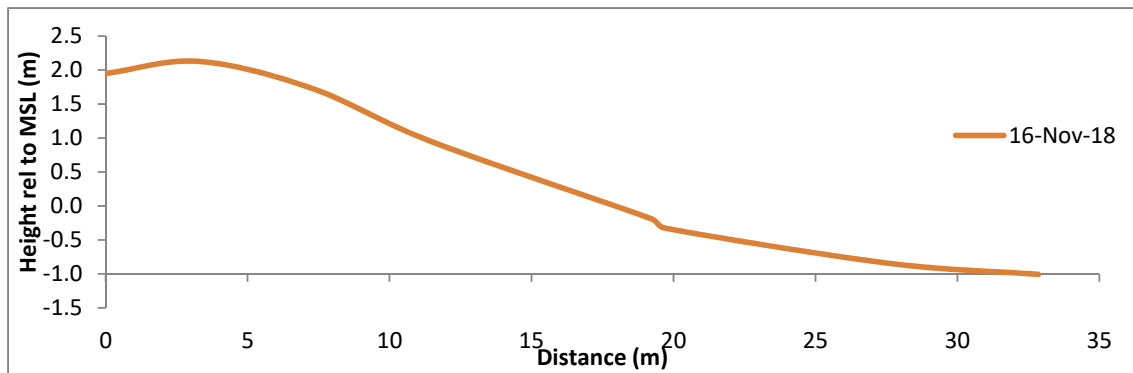
Figure 31. Beach profile P05 showing shoreline characteristics on November 2018 at Vandhoo.

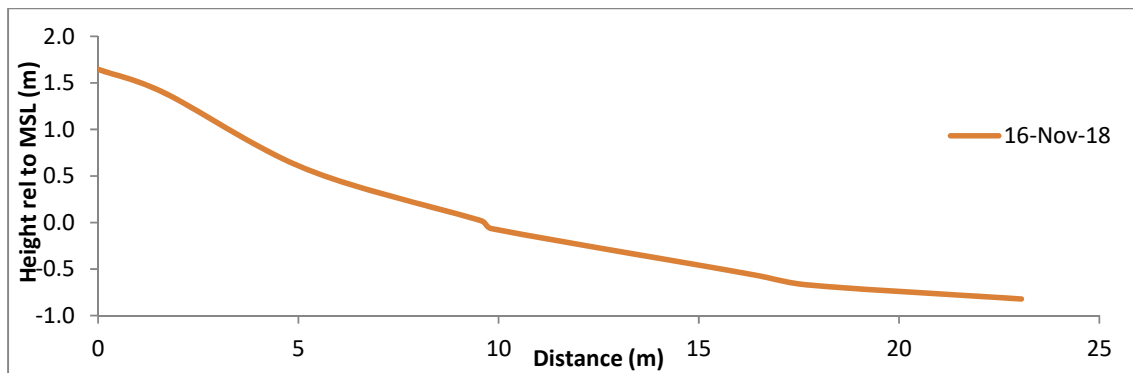
Figure 32. Beach profile P06 showing shoreline characteristics on November 2018 at Vandhoo.

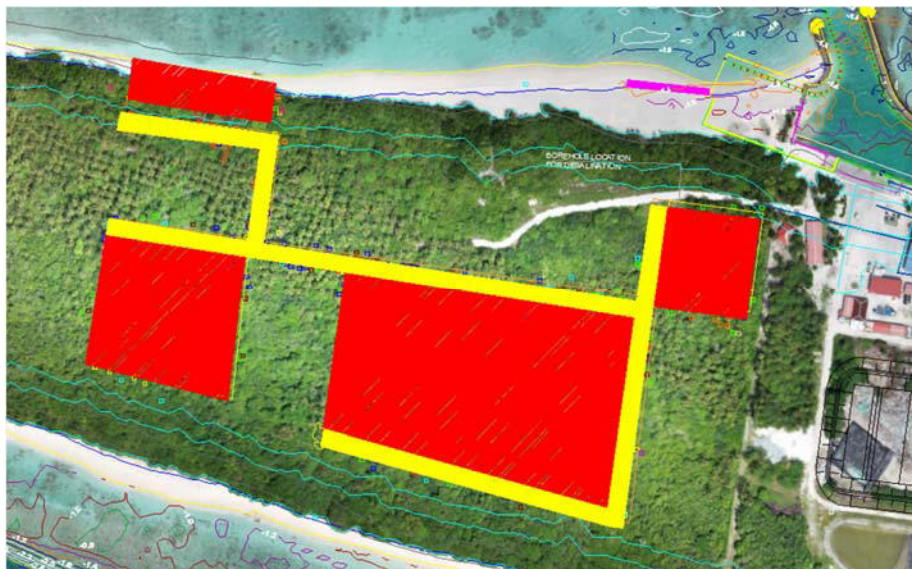
Figure 33. Areas which require vegetation clearance to develop the plots (red) and roads (yellow) as per the proposed master plan

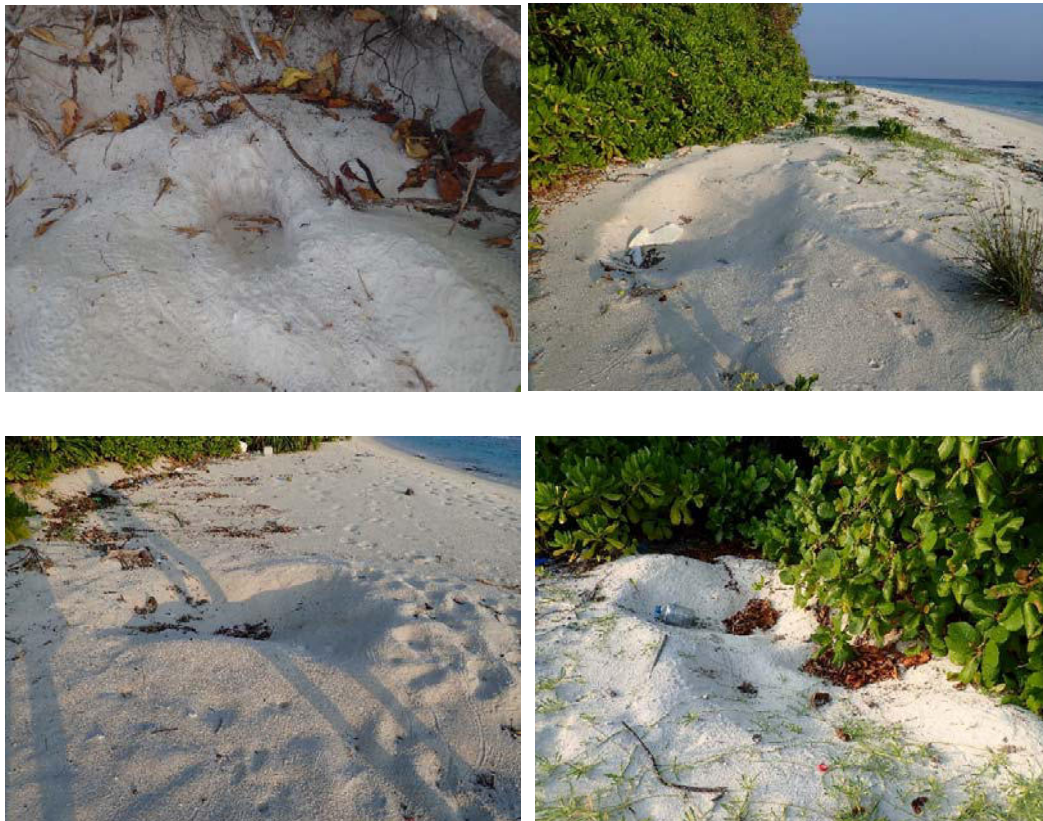
Since Vandhoo is identified as a turtle nesting site, evidence of turtle nesting sites was assessed by walking on the beach and visually inspecting the beach for signs such as nesting pits and turtle crawls. As such, about 4 turtle nesting pits were observed during the site visit in November 2018. Absence of tracks at these pits indicated that the pits were about few weeks to few months old. Human exploitation was observed at all 4 pits. The nesting pits were not necessarily confined to the turtle conservation area identified in the Masterplan (Appendix 4), but rather, the nesting pits were observed all around the island.

Figure 34. Evidence of turtle nesting pits observed at Vandhoo

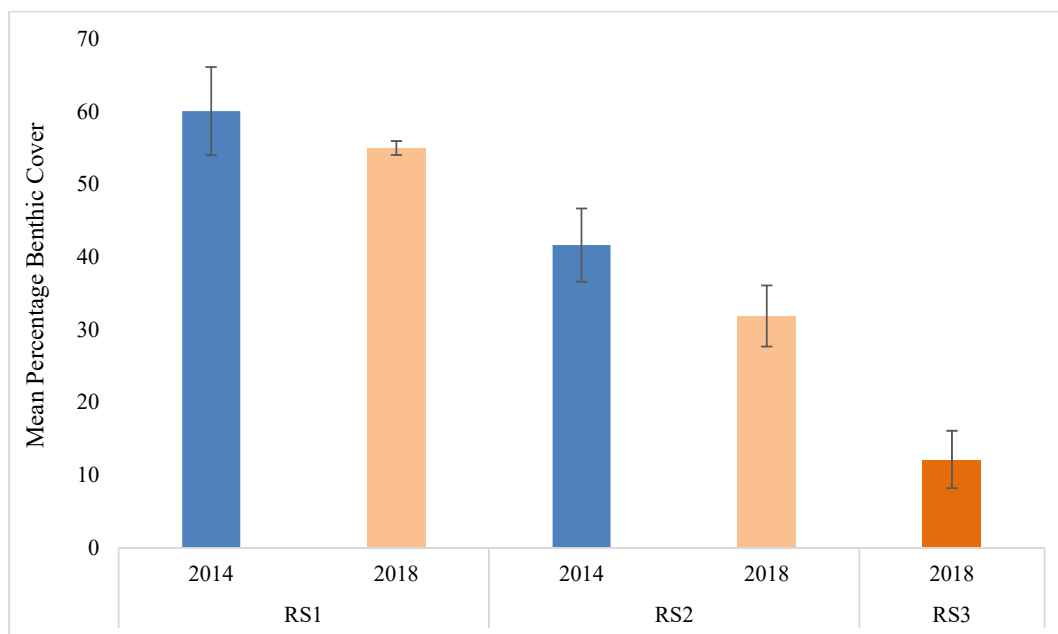
Figure 35. Comparison of mean percentage live coral cover at RS1 and RS2 during the 2014 monitoring survey and the 2018 ESIA survey, and the mean percentage live coral cover at R3 during the 2018 ESIA survey.

The mean percentage coral cover decreased slightly at RS1 from 2014 to 2018 and decreased at R2S as well between 2014 and 2018 (Figure 35). During the 2018 survey, the mean percentage coral cover was the lowest at RS3 (Figure 35).

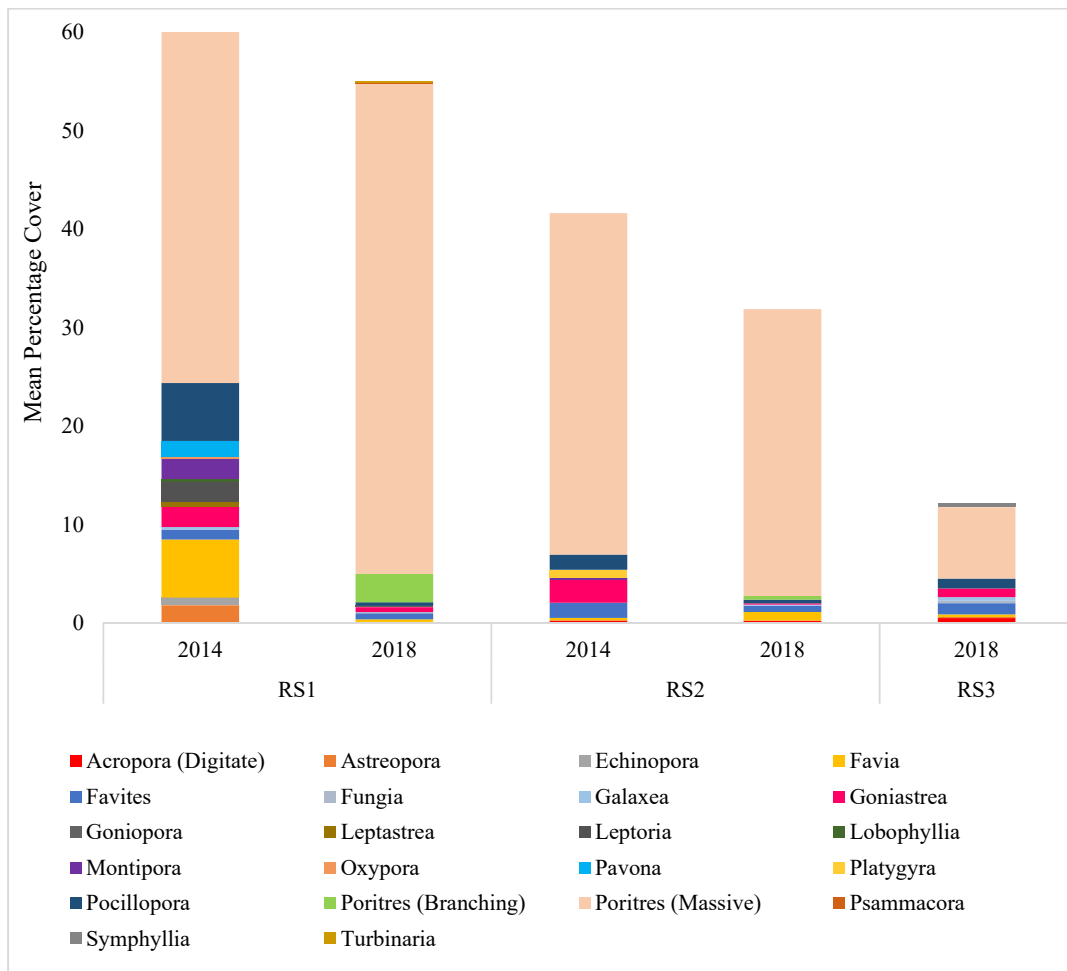
Figure 36. Percentage composition of hard coral at R1 and R2 during the 2014 monitoring survey and 2018 ESIA survey, and the mean percentage live coral cover at R3 during the 2018 ESIA survey.

Porites (massive) was the most dominant type of coral across all three sites during both the 2014 and 2018 ESIA survey (Figure 36). The mean percentage cover of Porites (massive) increased from 35.71% to 49.75% from 2014 to 2018, and the mean percentage cover of Porites decreased from 34.68% to 29.13% from 2014 to 2018 at R2 (Figure 36). During the 2018 survey, the mean percentage cover of porites was the lowest at R3 at 7.25% which was considerably lower compared to the other two sites. There was no Acropora found at R1 during both survey years and the mean percentage cover was less than 1% at R2 during both survey years and less than 1% at R3 (Figure 36)

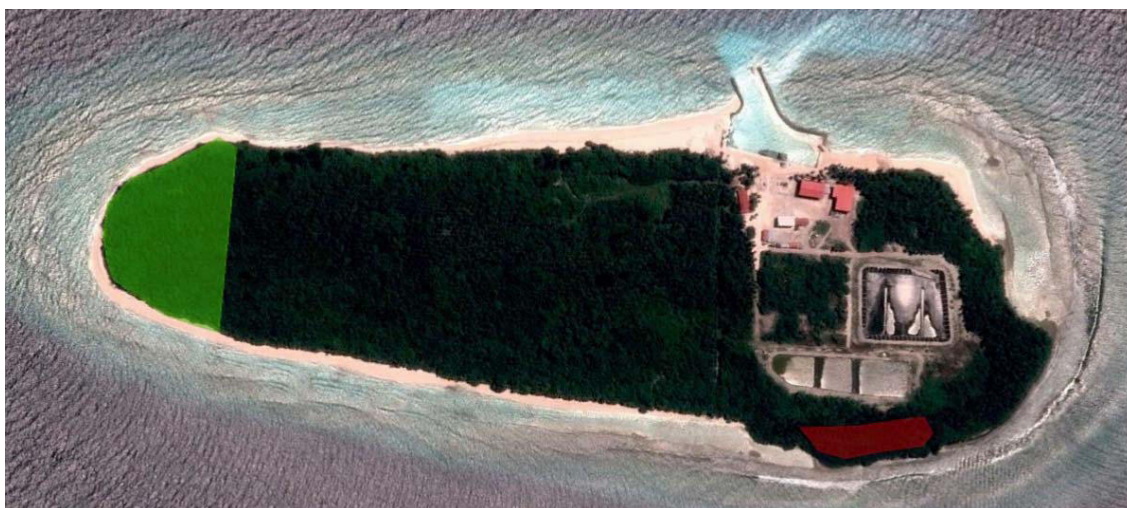
A small mangrove area exists at the southeastern periphery of the island just below the leachate ponds (Figure 40). This area is preserved and no development activities will reach this area. Moreover, an area of about 42,400 m² at the western tip (Figure 40) of the island is preserved for turtle conservation under this project, however, turtle nesting is not necessarily confined to the area marked as a turtle conservation area on Figure 40. Vandhoo was reportedly a nesting site for hawksbill turtles (*Eretmochelys imbricata*) (Riyan and NIRAS, 2012).

Figure 40. Area with mangrove (red highlight) and turtle conservation area (green highlight).

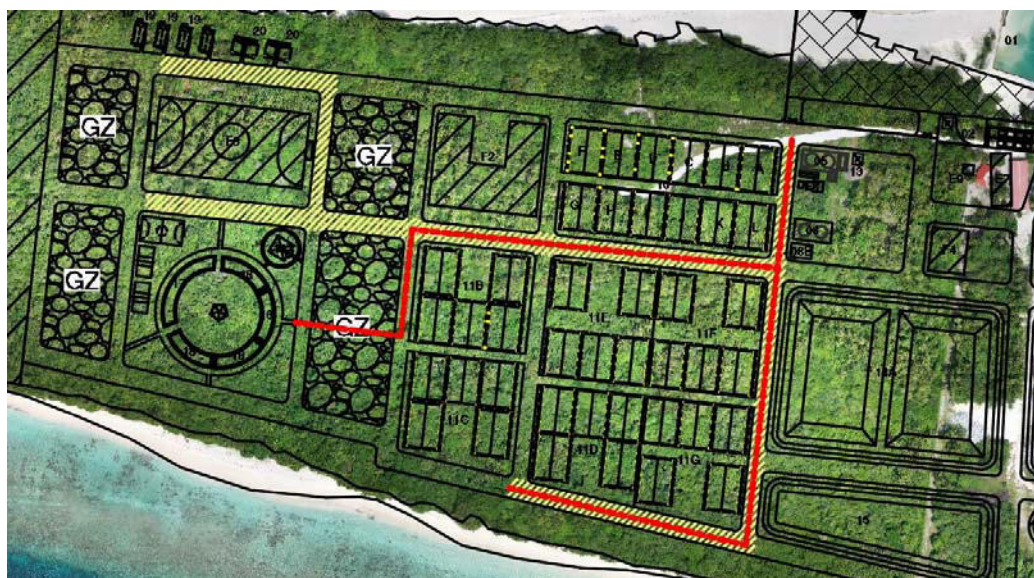
Figure 43. Proposed road network (yellow highlight) and alternate road network (red) for RWMF at Vandhoo

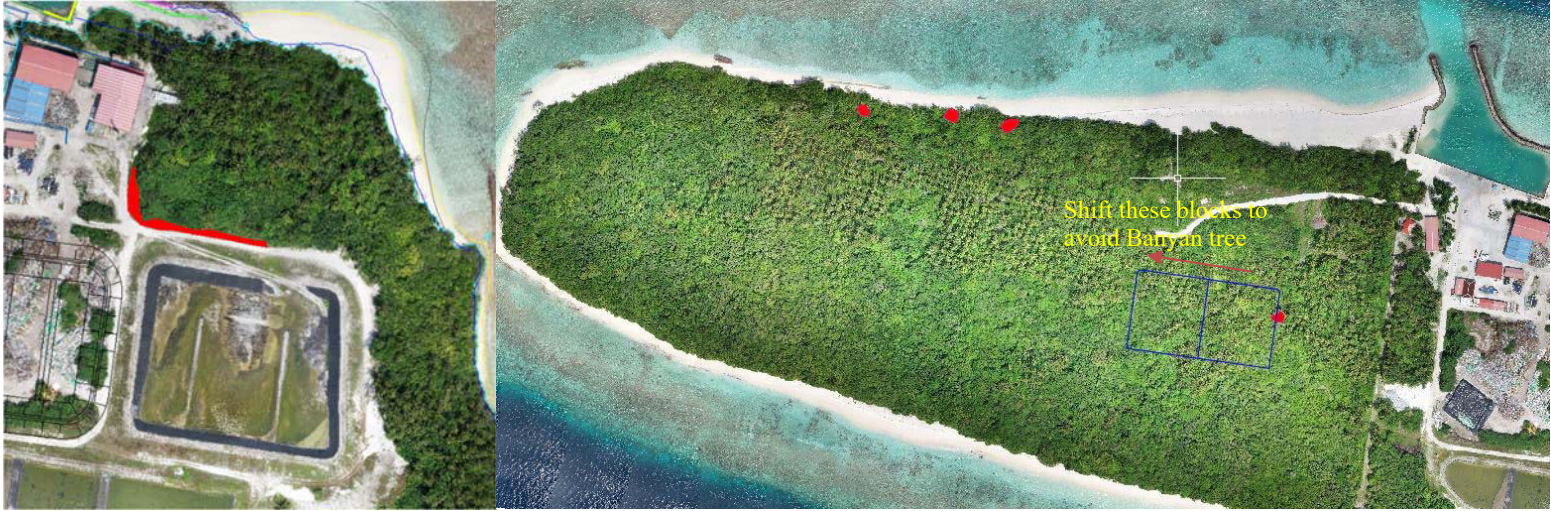
Figure 44. Area proposed for relocation of some of the removed coconut palms (left). Locations of Banyan trees (right).

The island having a thick vegetation, vegetation clearance was identified as the impact with highest significance (B/E3). Moreover, most building plots were proposed at areas with a thick coconut grove. In addition to heavy vegetation, changes in endemic terrestrial flora and fauna due to construction and operation phase are also identified. Few protected banyan trees were identified, one of which falls on a construction plot (Figure 44).

<p>harmd in any way. Coconut palms removed from the construction sites, if not replanted, should be taken to a nearby island and rehabilitated. An alternative option for road widths are described in section 8 in order to minimize the no. of coconut palms to be removed. Plant some of the cleared vegetation on either side of the roads as well as the areas shown on Figure 44.</p> <p>Beach front guest accommodation blocks are not recommended, instead, allocate guest rooms at the proposed staff accommodation block as discussed under project alternatives section.</p> <p>Few protected banyan trees were identified, one of which falls on a construction plot (Figure 44). It is recommended to shift the block to avoid the banyan tree. All banyan should be conserved during and operation of the facility.</p>			
Overall construction and operation of the project	BE6	Changes in turtle nesting patterns due to changes in beach areas due to construction, noise and lights	Document the relative importance of the beaches as nesting areas for each turtle species, if considered important, take measures such as infrared lights at night, turtle protection measures. No trespassing signs shall be enacted at the turtle conservation area and the area should not be disturbed by any means. Any exploitation, if reported shall be punished.	Turtle conservation area	None	ME, Construction supervisor EPA,
