KULHUDHUFFUSHI HARBOUR EXPANSION PROJECT

GEO TECHNICAL INVESTIGATION REPORT

NOVEMBER 2017

GEOTECHNICAL INVESTIGATION FOR PROJECT MANAGEMENT CONSULTANT FOR KULHUDHUFFUSHI HARBOR EXPANSION PROJECT, MALDIVES

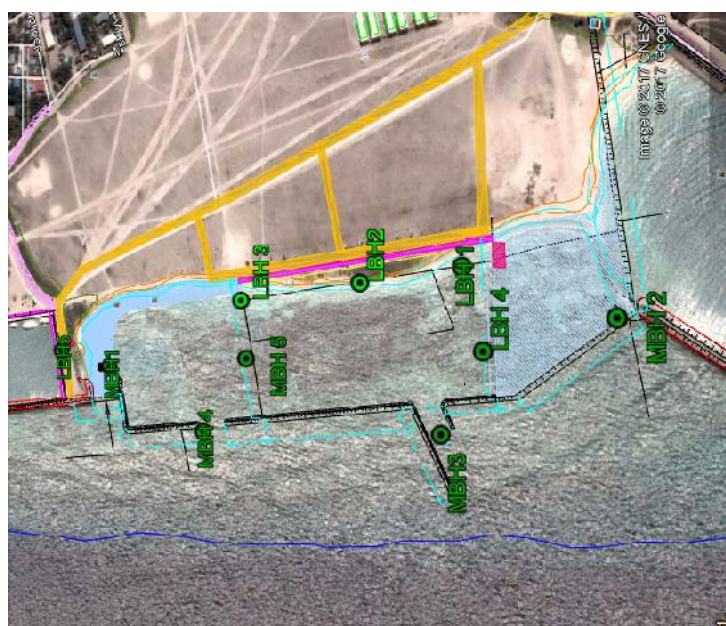
Fig 1 Geotechnical Investigation locations

The investigated boreholes are at Kulhudhuffushi harbour premises for expansion of Kulhudhuffushi harbour. The location map shows the points where the Geotechnical Investigations are carried out.

Field investigation consisted of advancing ten boreholes at the locations marked in Figure 1. The Field investigation was commenced on 23rd September to 17th October.

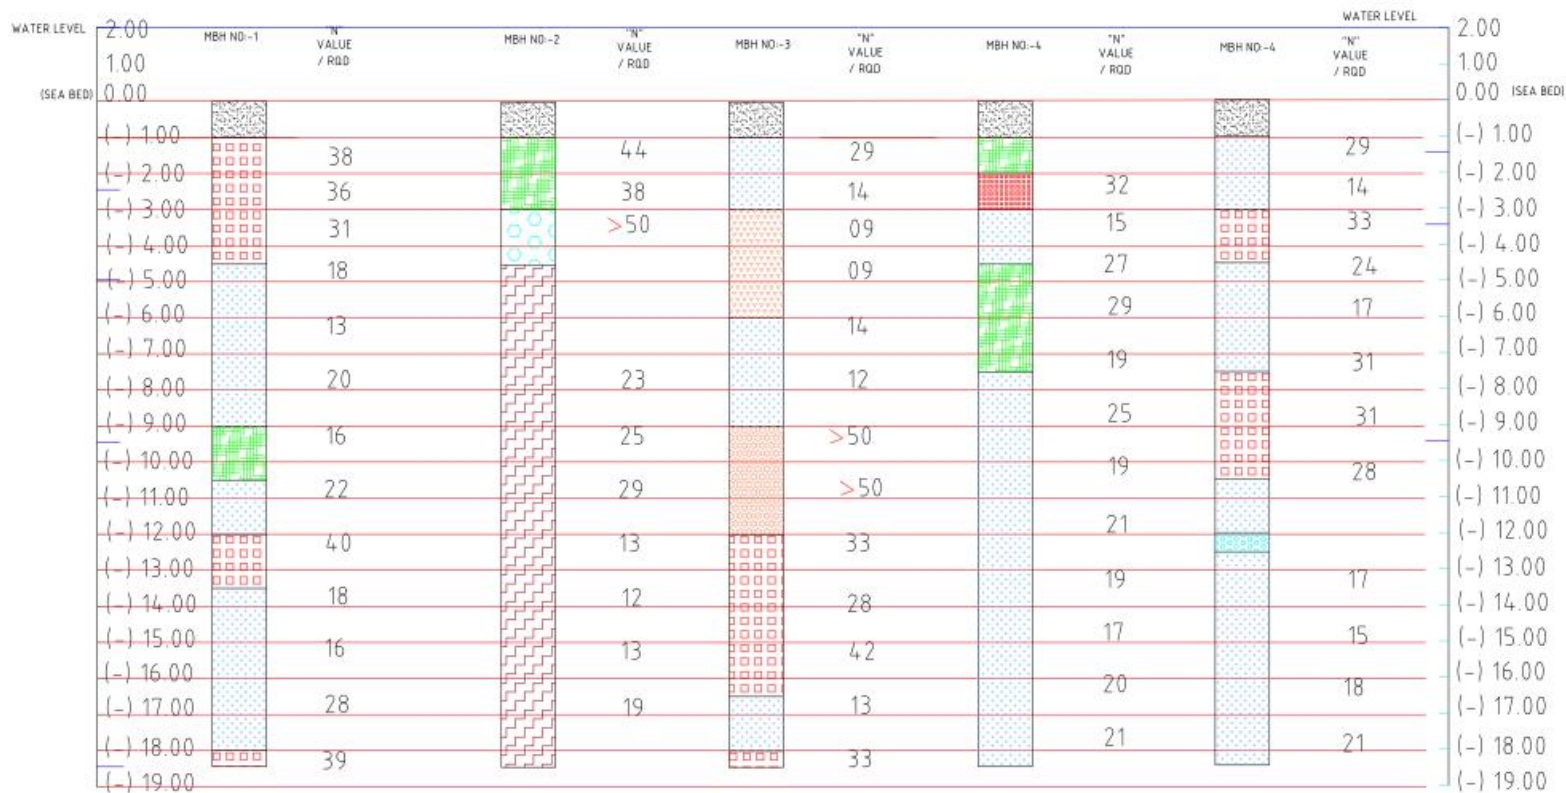
SUB - SOIL PROFILE (MBH 1 to MBH 5)

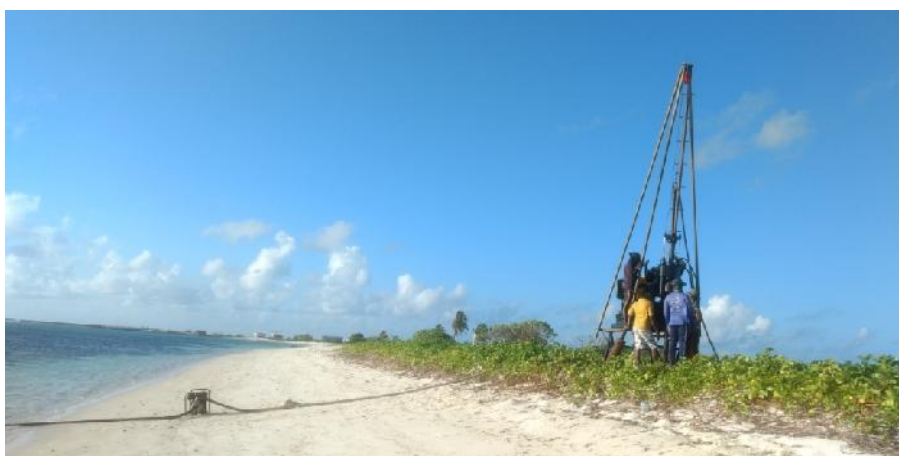
Drilling of Bore hole at LBH-02 location

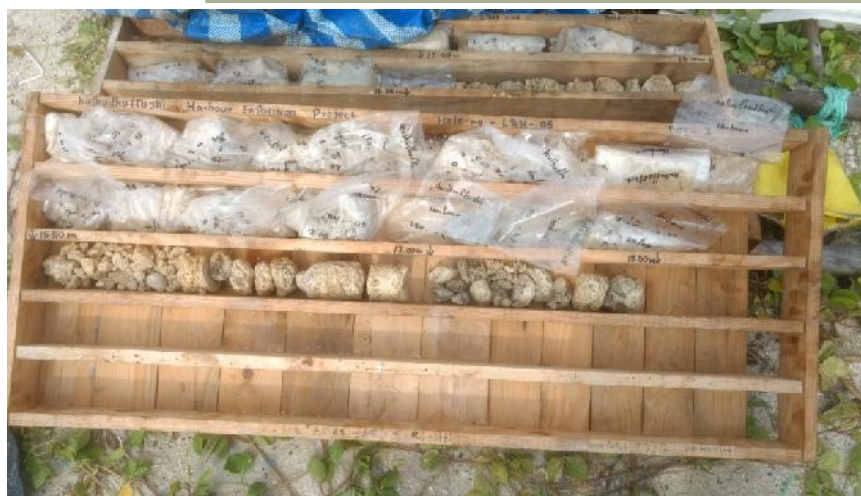
Core Box for LBH-05 location

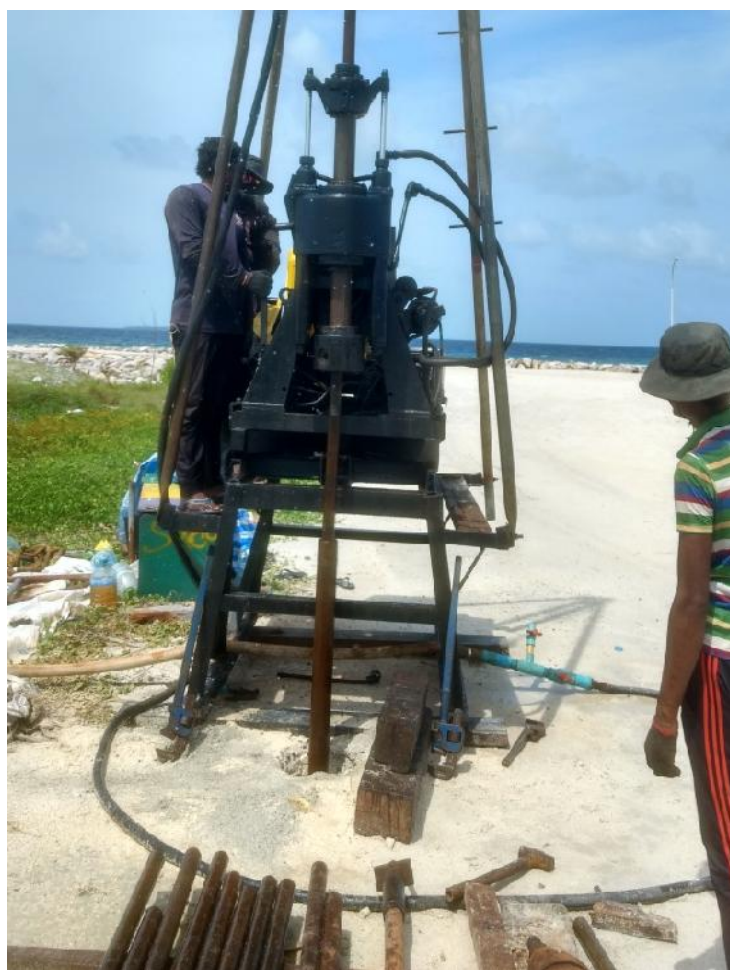
Drilling of Bore hole at LBH-05 location

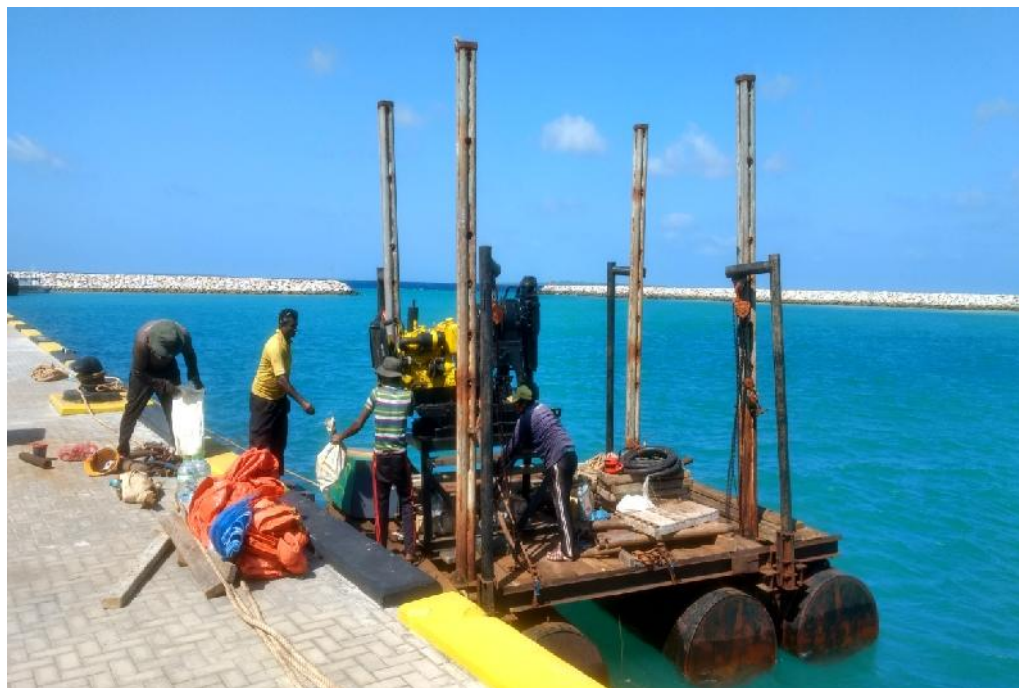
Jack-up Barge Assembling for conducting Marine Boreholes

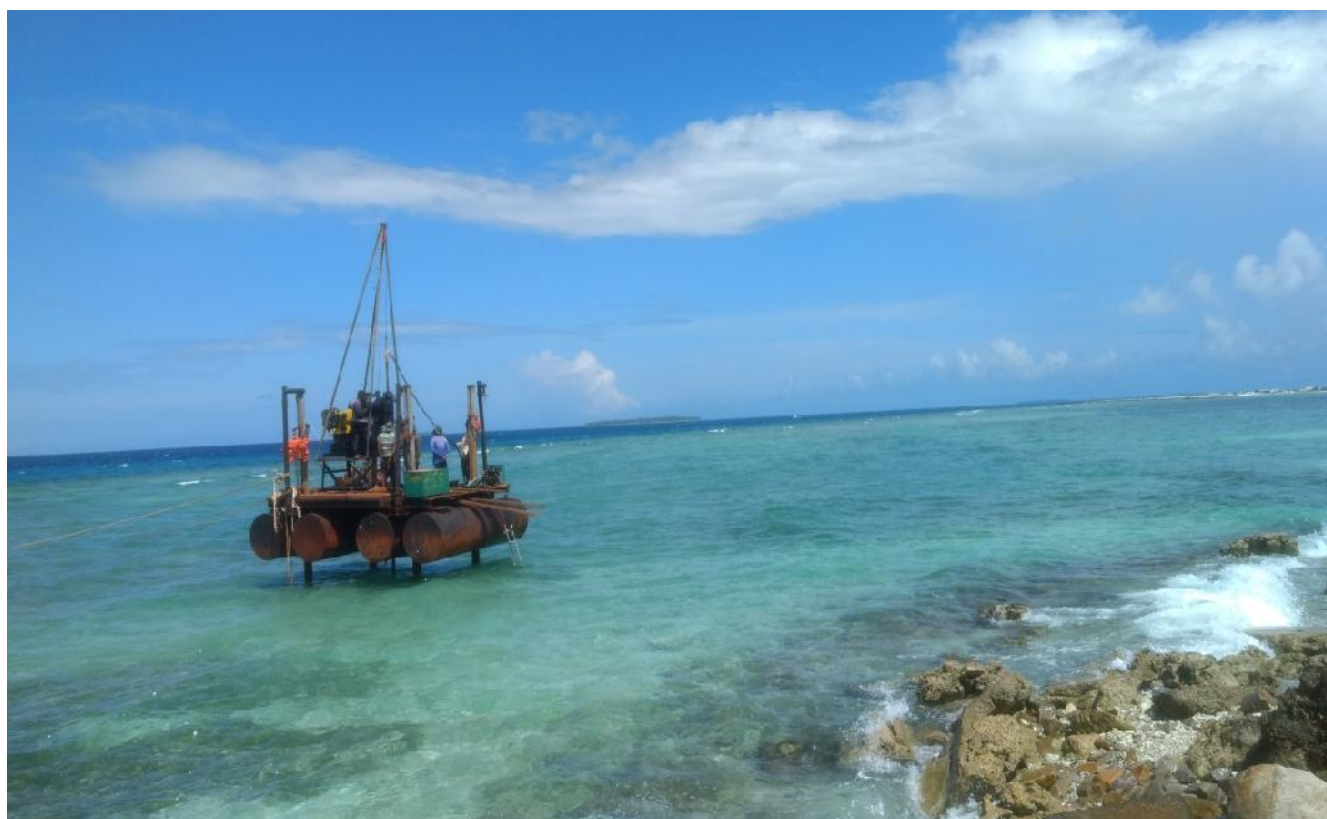
Drilling of Borehole at MBH – 02 location

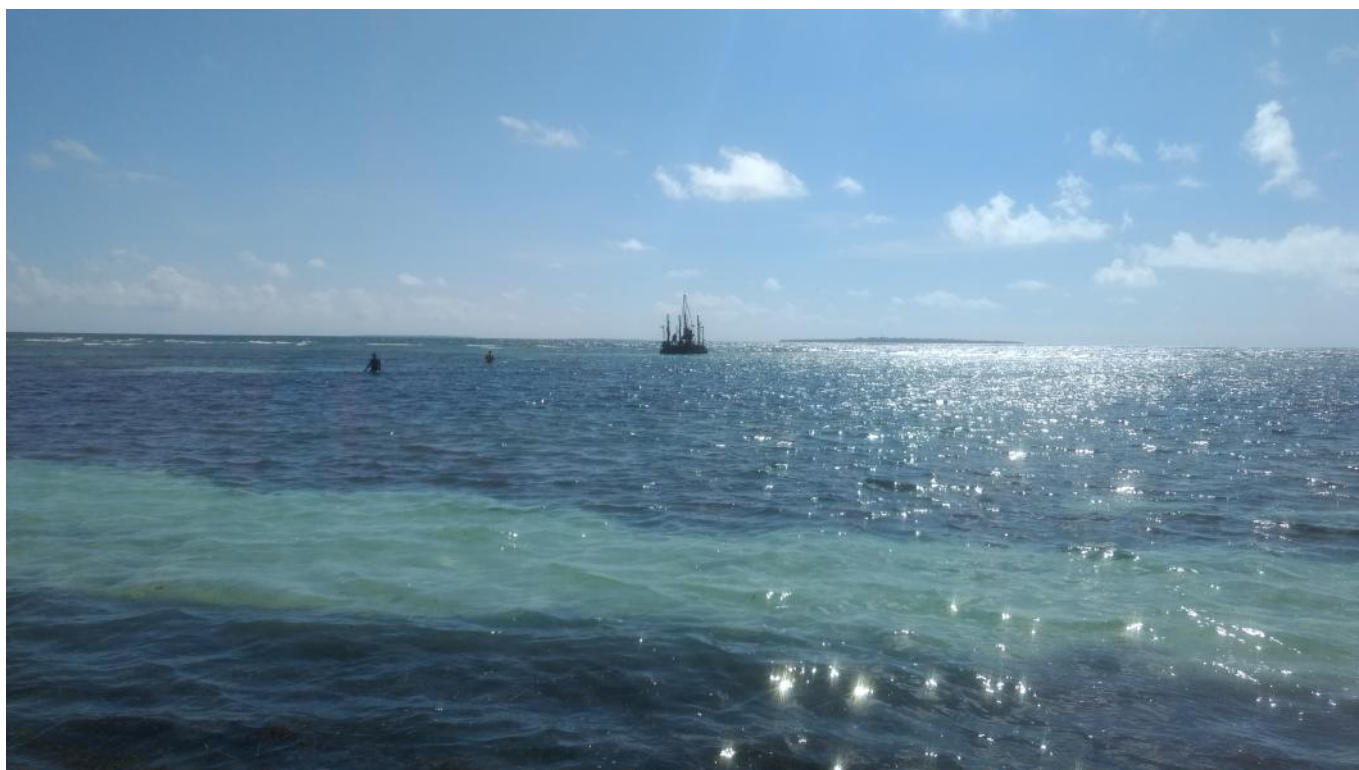
Jack up Barge at MBH – 03 location

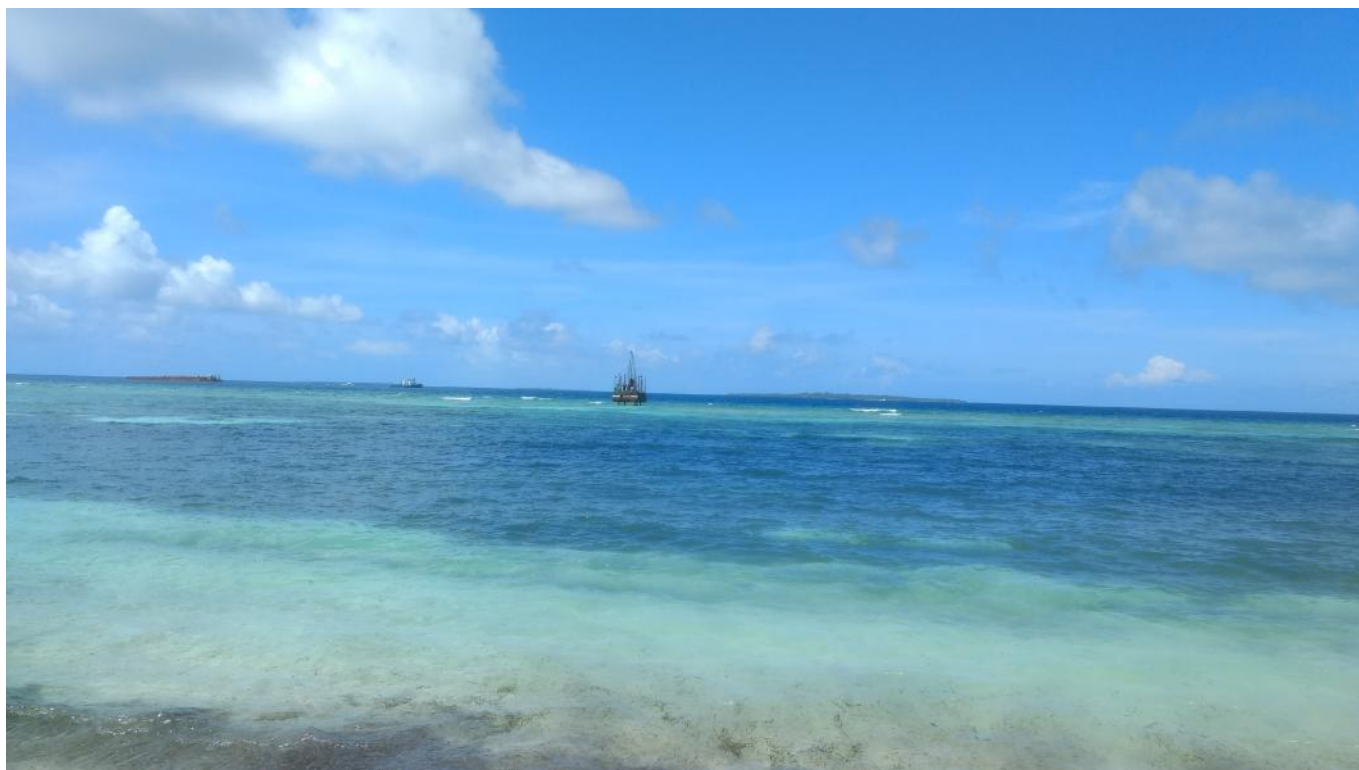
Drilling of Borehole at MBH – 03 location

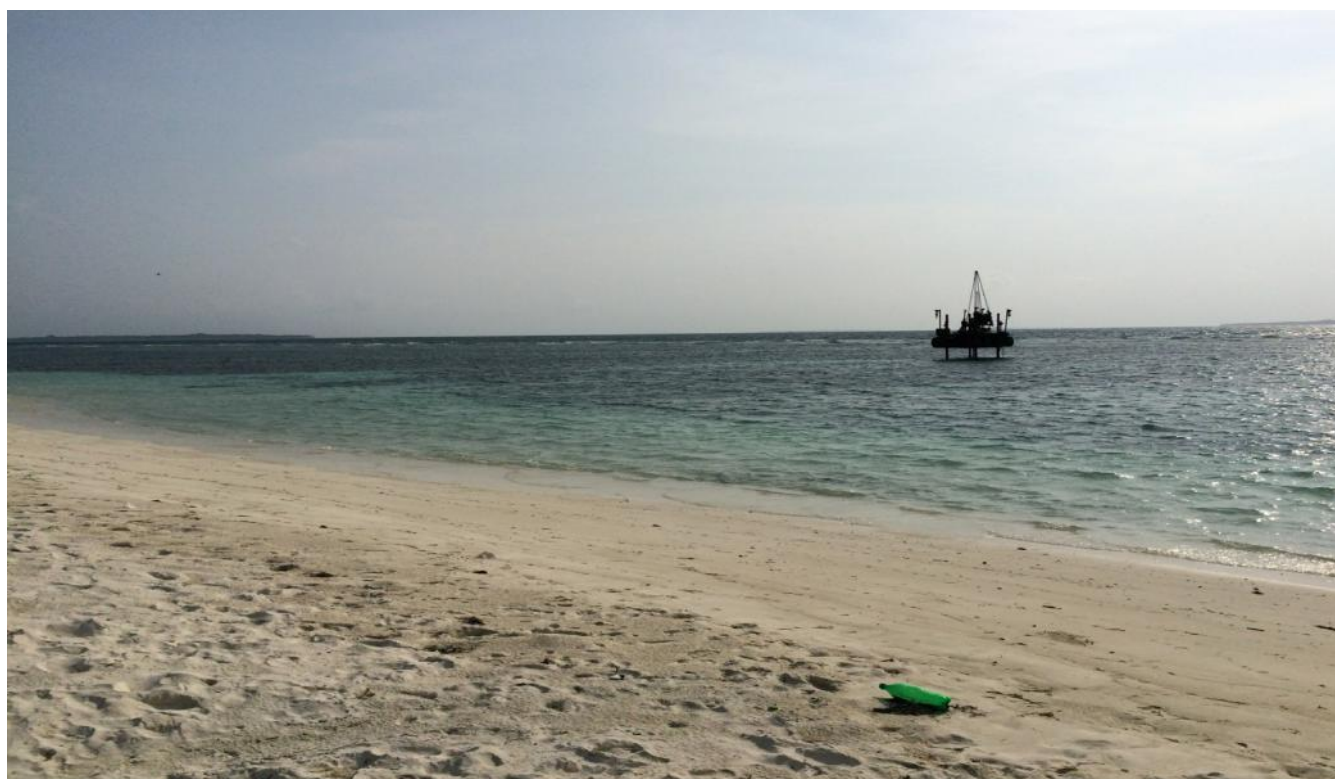
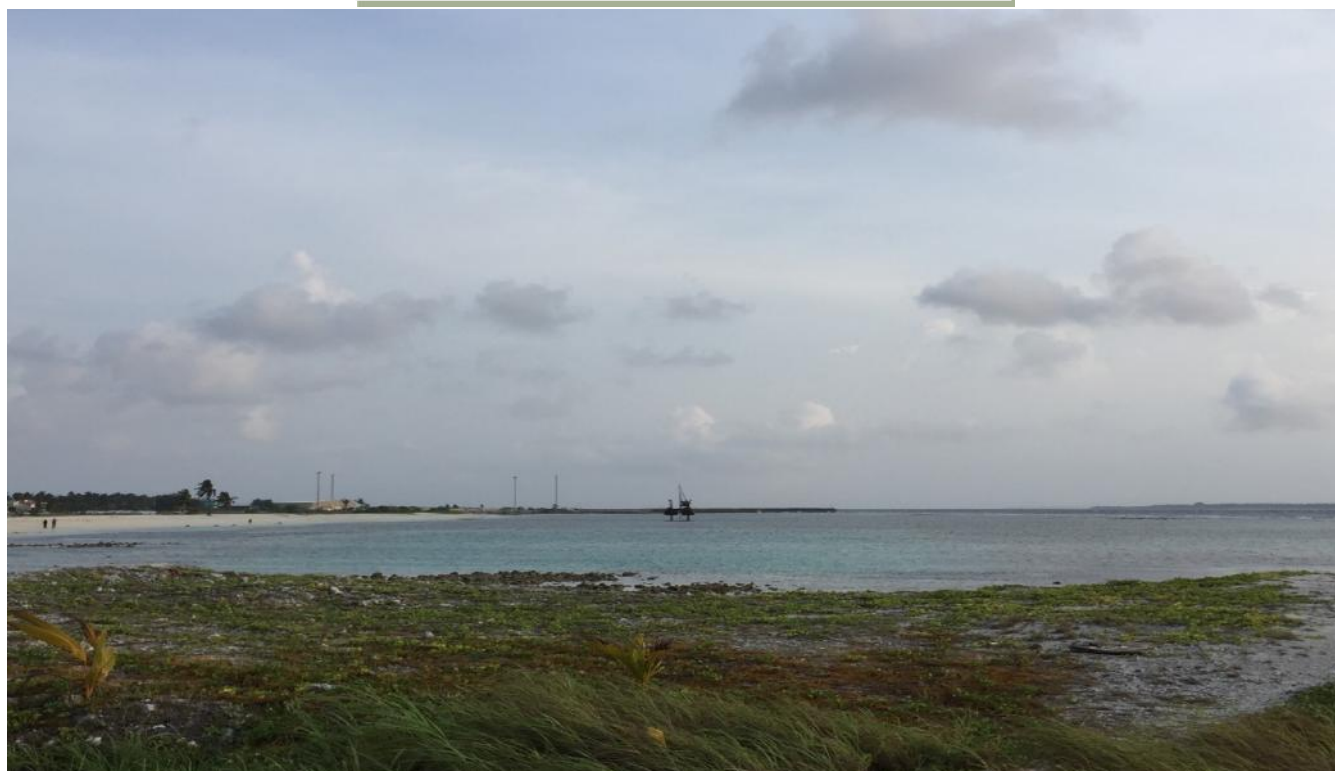
Drilling of Borehole at MBH – 05 location

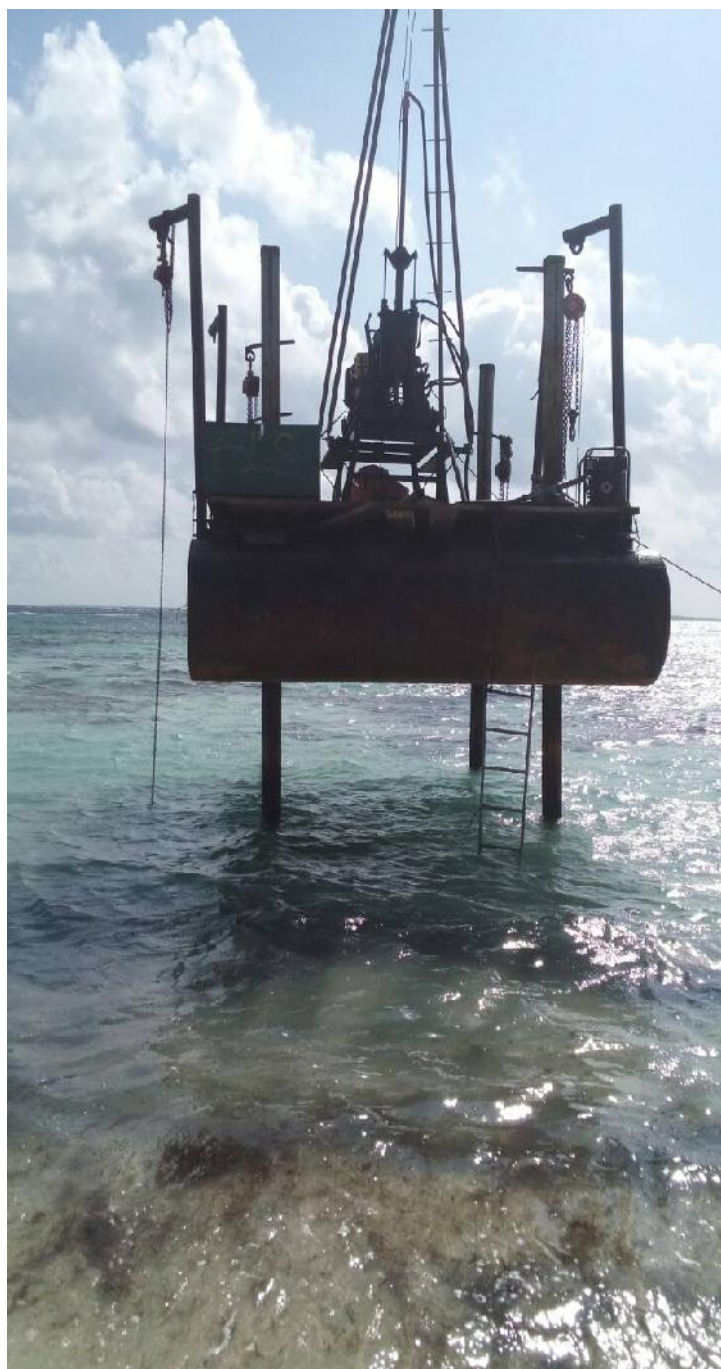
Drilling of Borehole at LBH – 01 location

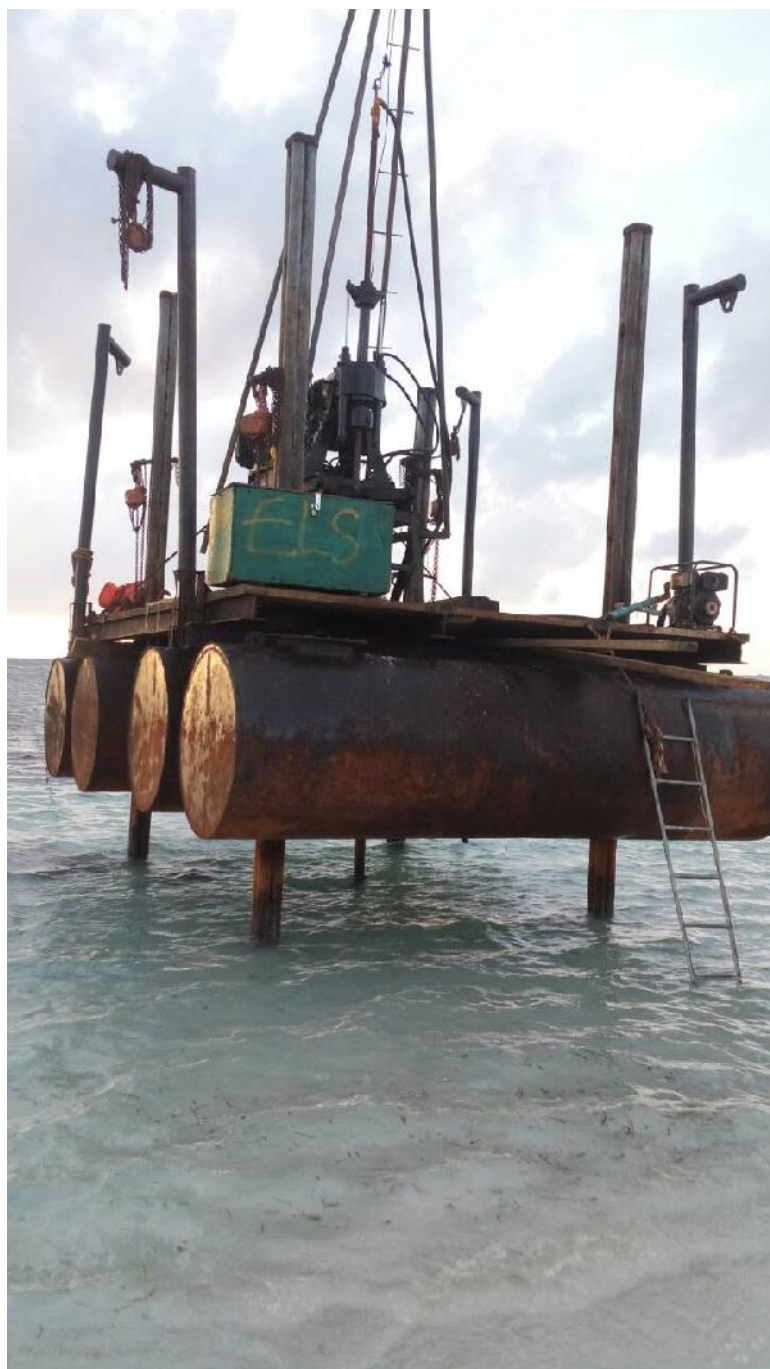
Drilling of Borehole at LBH – 03 location

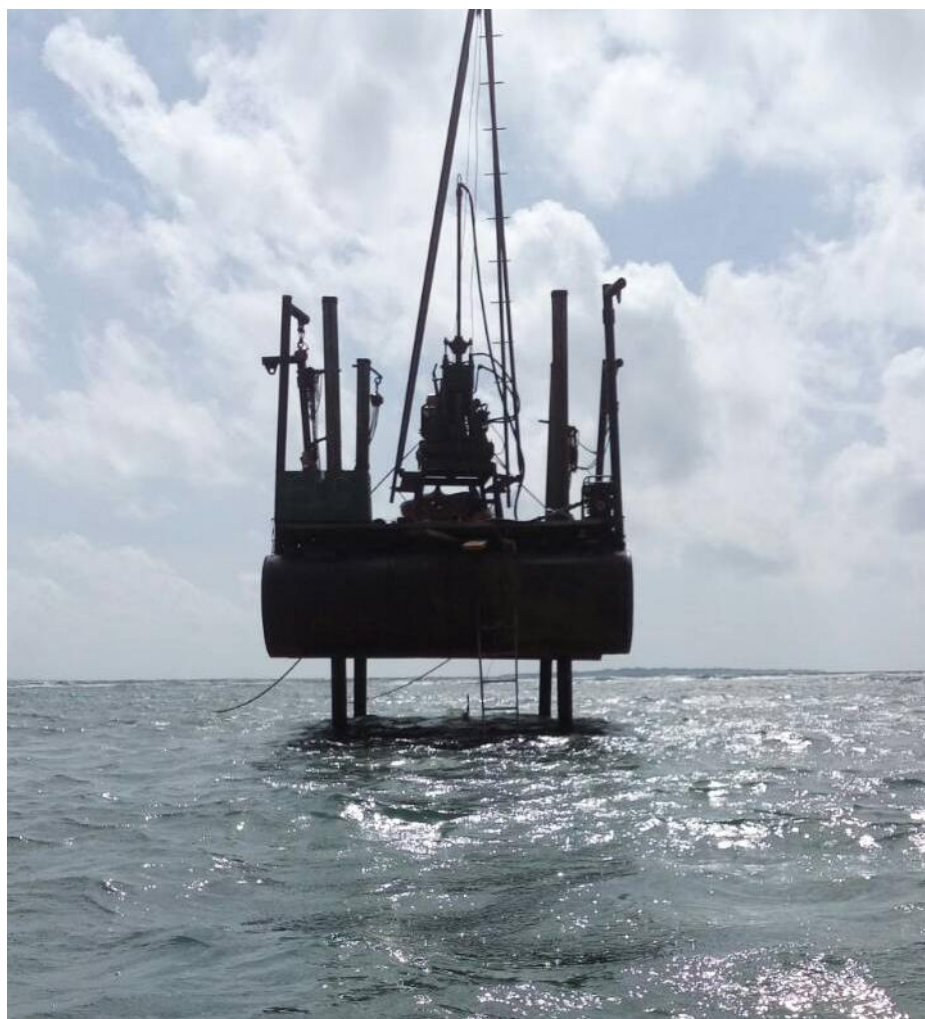
Drilling of Borehole at LBH – 04 location

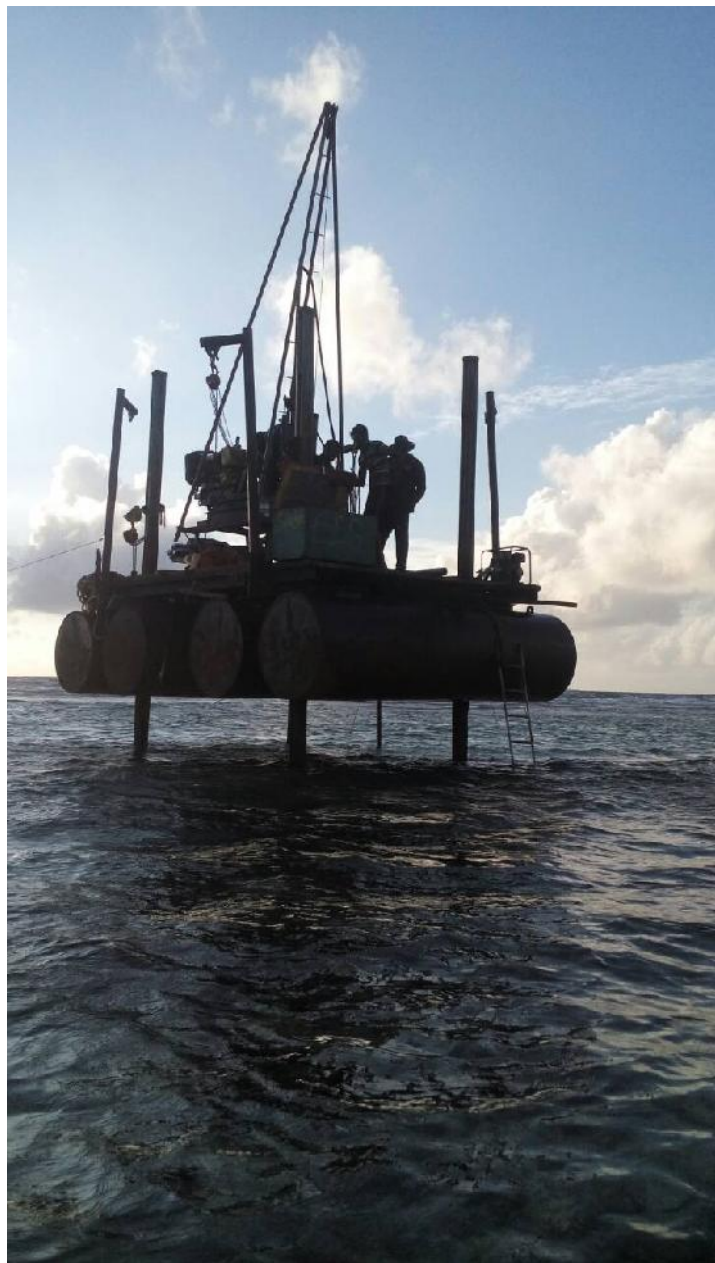
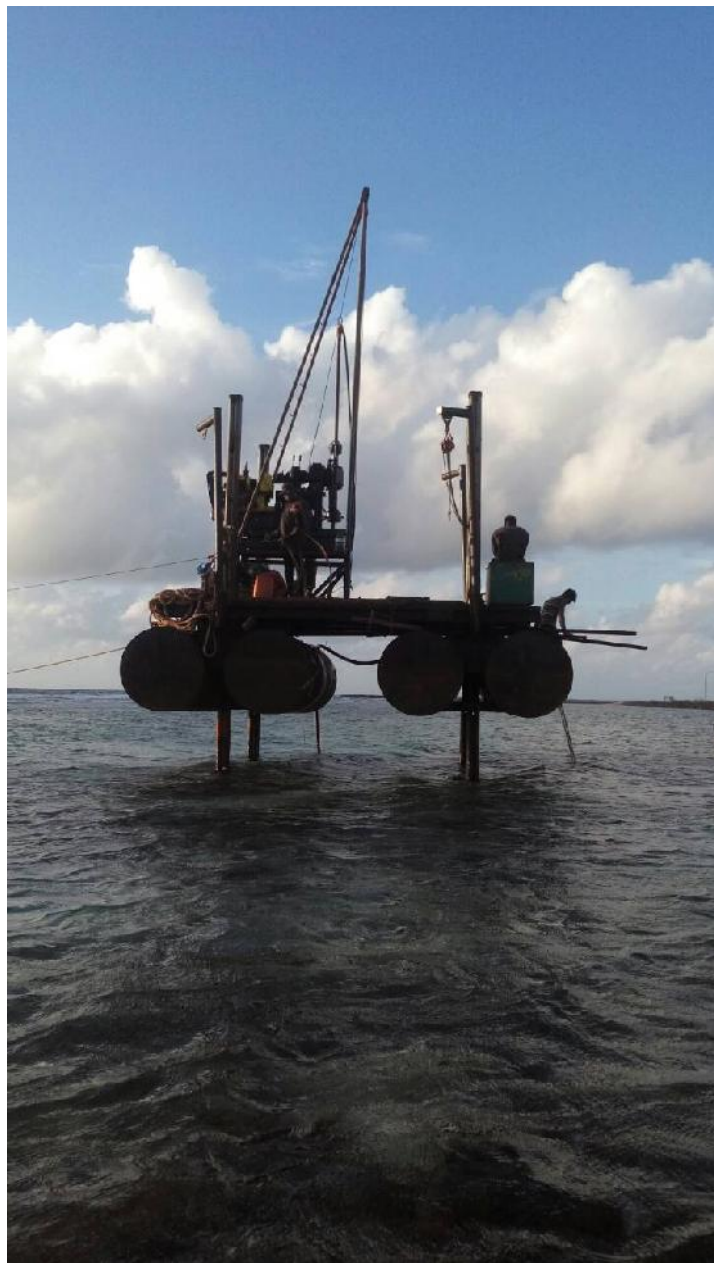
Drilling of Borehole at MBH – 04 location
