Environmental and Social Impact Assessment Report

Upgrading of infrastructure at Regional Waste Management Facility Zone II, Raa, Vandhoo

Ministry of Environment

January 2019

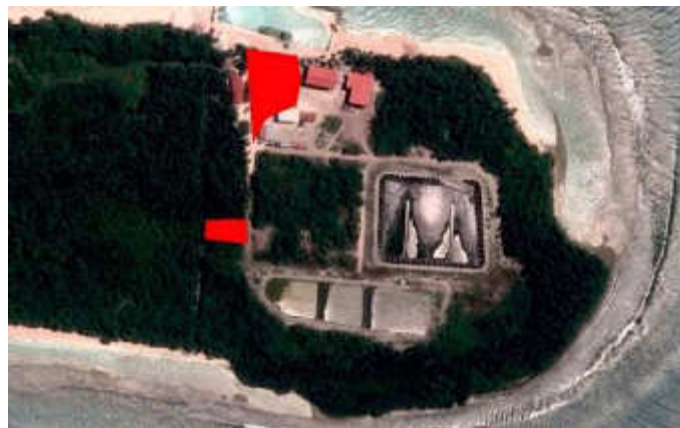
Figure 6. Recommended areas for temporary material storage

Construction material for the project, such as building material, galvanized iron pipes and nets will be brought to the island on bigger vessels. Materials will be unloaded to the island at the existing harbor. Construction materials will be temporarily stored at the areas indicated on Figure 6 below as these areas are currently barren. Vegetation clearance for temporary storage is not recommended. Once the land gets cleared for building plots, some material can be moved about to those areas as well.

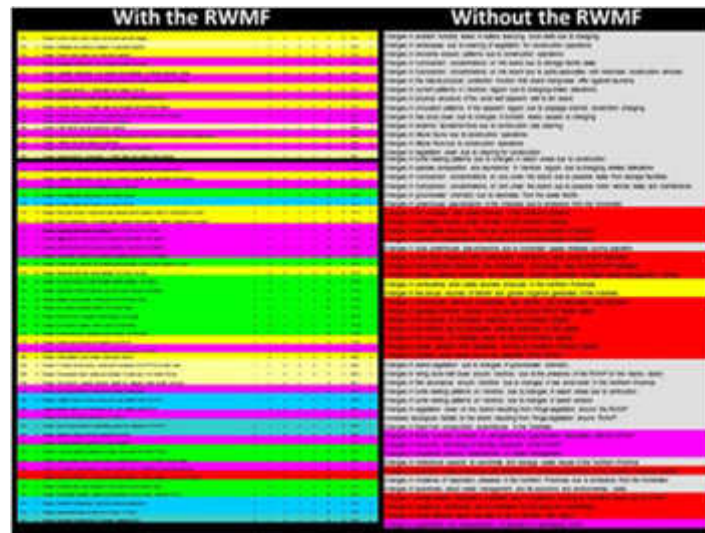
Figure 12. Graph showing the results of the RIAM analysis of the scenario with the RWMF and the scenario without it.

Figure 12 shows the results of the RIAM analysis of two scenarios - with and without the RWMF project at Vandhoo. In the figure it is easy to compare two scenarios using the different color bands. The red and magenta color bands highlight those potential changes that require a *pre-project baseline*, as well as *mitigation measures* and *monitoring* of the effectiveness of those measures based on changes in the baseline for each of the relevant physical-chemical (P/C), Biological/ecological (B/E), social-cultural (S/C) and economic-operational (E/O) components changes caused by the project.

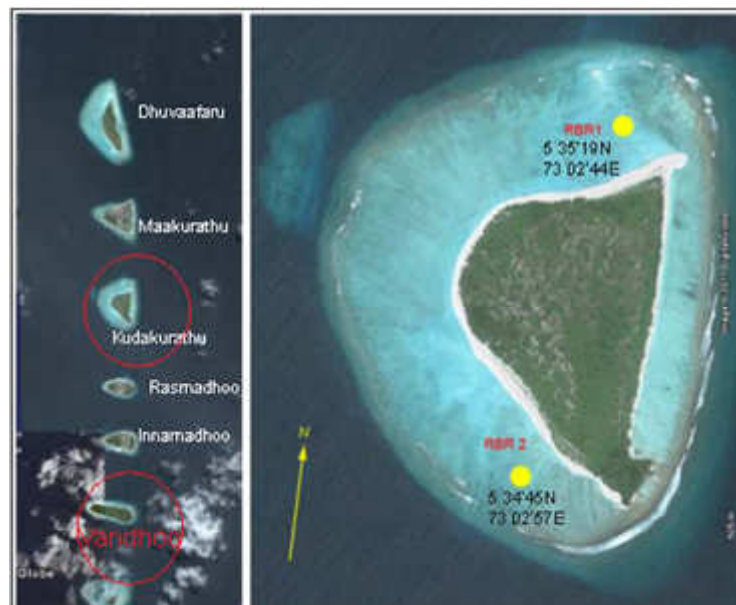
Figure 20. Location of Kudakurathu with respect to Vandhoo and location of wave gauges

Since site specific wave data is not available for Vandhoo; data collected at a nearby island (located at the eastern periphery as Vandhoo) was used to understand the wave climate of the area. The island of Kudakurathu is proposed for resort development and as part of Environmental data collection; LaMer Pvt Ltd has collected wave and tide data from this island. The island of Kudakurathu is approximately 4.7 km north of Vandhoo (Figure 20 shows location of Kudakurathu and wave gauge). RBR model TWR 2050 was used to collect wave data at 30 min interval burst.

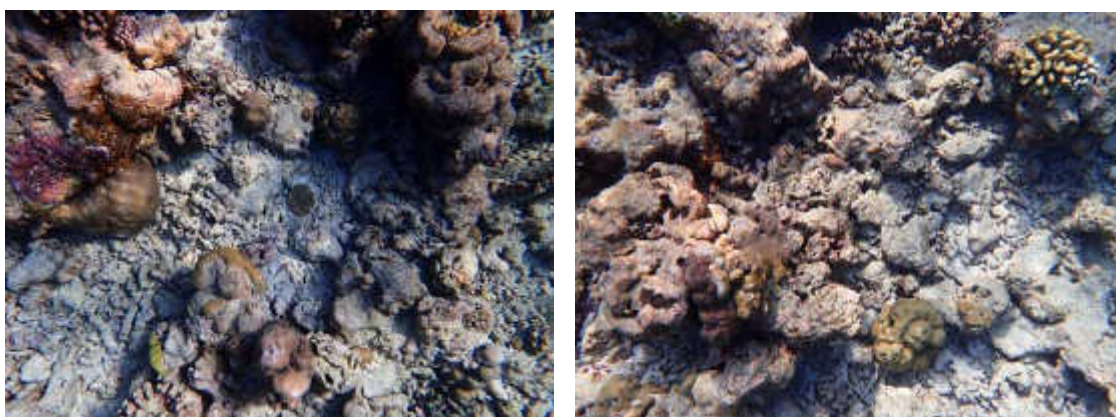
Figure 39. General condition of the reef at site RS1, as of November 2018.
